M1 Junction 15
Northampton Rail Freight Interchange

Stage 1 Road Safety Audit

Document Number:	NGW-BWB-GEN-XX-RP-TR-001_RSA1
BWB Reference:	NTH2315

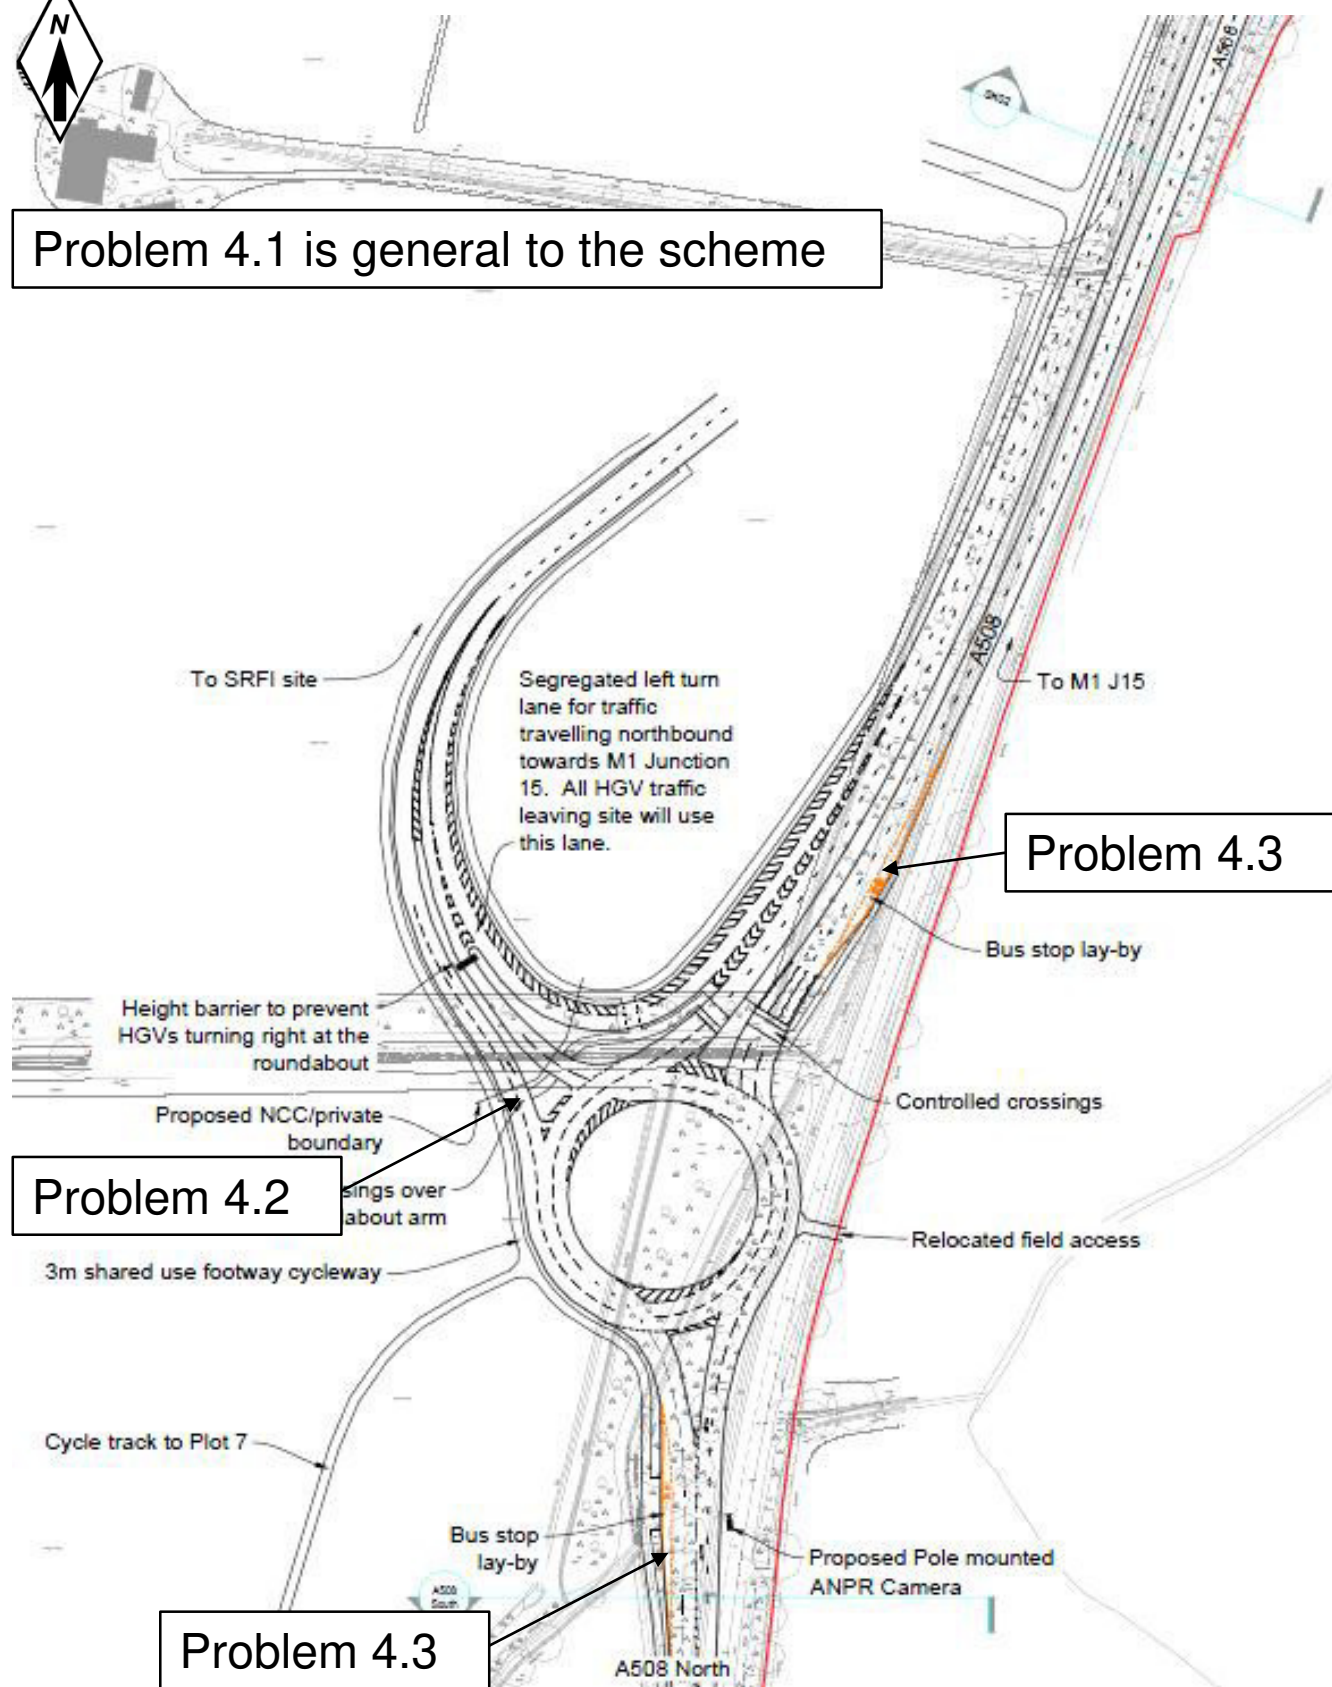
The road markings as currently proposed are not clear. For example, on the site access the centreline is not central. In addition, directional road markings as well as arrows will be required at the roundabout to make it clear as to what movement is permitted in each of the entry lanes. As a result, this could result in vehicles not taking the correct line of travel if they were guided by the road markings as currently proposed.

Summary: Uncontrolled crossings provided on potentially busy exit from roundabout.

The crossing facility provided over the site access arm is proposed as an uncontrolled crossing. However, the access will potentially be busy during peak times, and the exit from the roundabout is provided with two lanes merging to one within the site. This could make it difficult for pedestrians to cross the carriageway and predict vehicle movements exiting the roundabout. This is exacerbated by the provision of two lanes allowing access to the site around the roundabout.

Summary: Provision of bus stop close to the roundabout could create confusion.

The proposals include bus stops provided on both the northbound and the southbound A508 approaches to the roundabout. The northbound bus stop in particular is provided close to the roundabout and is also provided in addition to a flare from one lane to

two lanes. This results in a potentially confusing layout, as a bus pulling into the bus stop, could be followed by a car, expecting it to turn into the site, for it to suddenly stop. This could potentially lead to shunt type collisions.

Similarly, the southbound bus stop could restrict visibility to and from pedestrians using the pedestrian crossing.

Problem 4.1 is general to the scheme

Problem 4.2

Problem 4.3

Ensure that the road markings and signage strategy at the site access junction is completely clear for all users.

Assuming pedestrian movements across the site access arm would be low, it could be beneficial to provide a signal controlled facility on the basis that it should not prejudice the capacity of said junction.

The bus stops should be located at a suitable distance away from the roundabout to prevent any confusion for motorists at the roundabout.

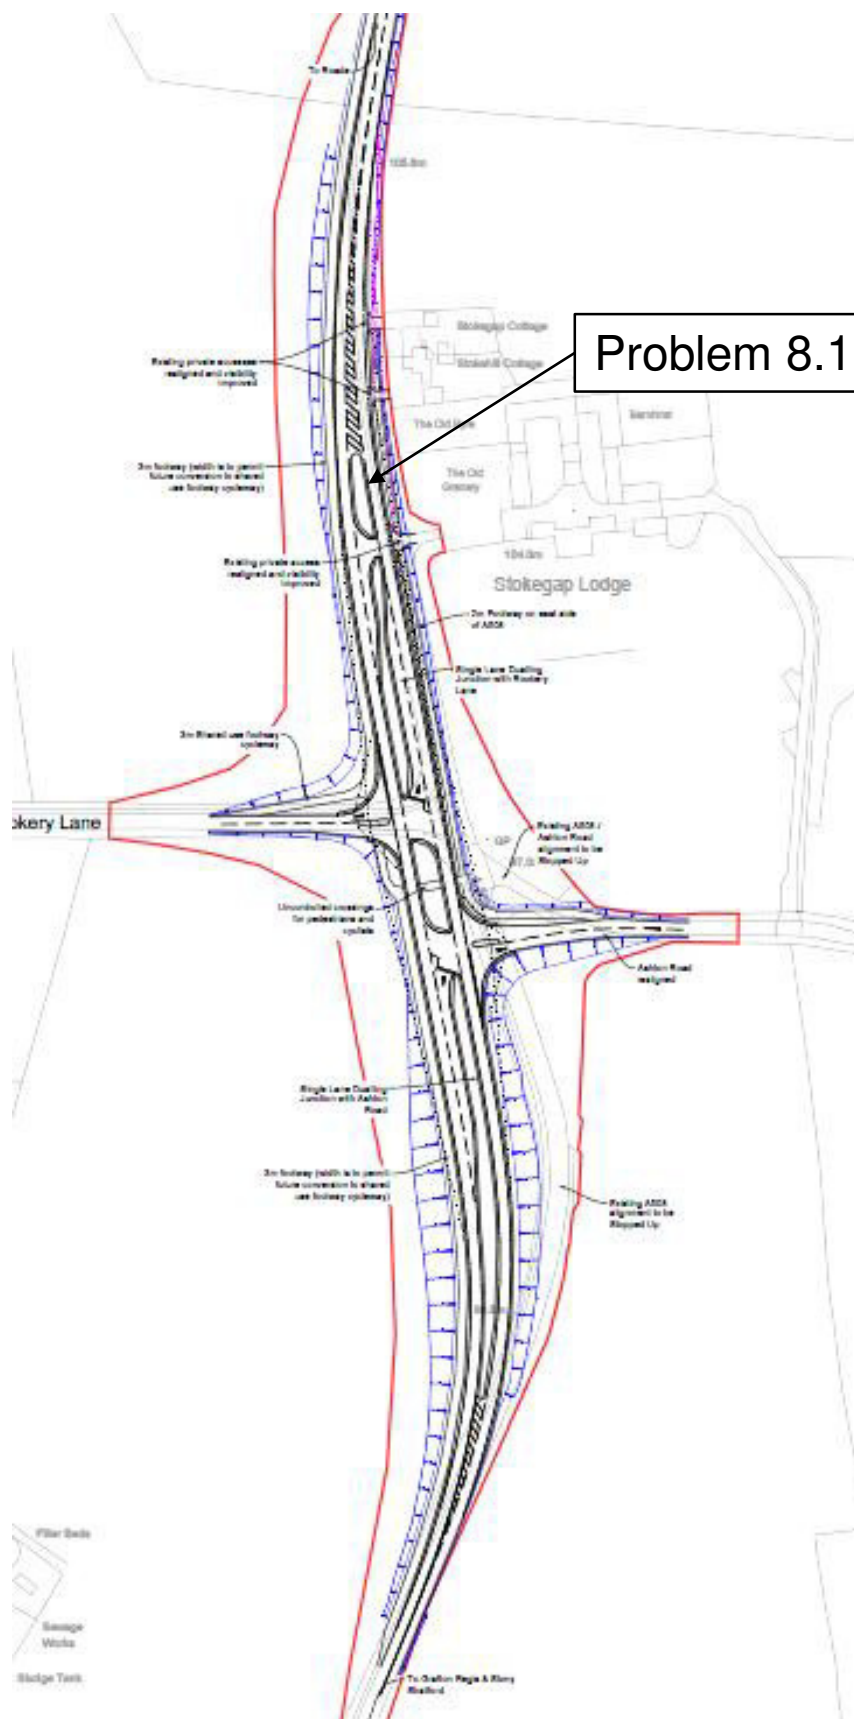
Location: Eastern side of A508 (Figure 7).

Summary: Lack of crossing facility provided between footways.

There is currently a footway provided along the eastern side of the A508 in the vicinity of the cottages, north of the proposed staggered junction. The proposals include a 3.0 metres wide shared facility on the western side of the A508. However, there is no facility provided to the north of the junction to allow pedestrians to cross the carriageway. This could result in pedestrians attempting to cross where there are no provisions or, where motorists are not expecting them to cross, resulting in them being hit by passing vehicles.

Provide an informal crossing facility across the most northern refuge, in the form of dropped kerbs and tactile paving to allow pedestrians to cross the road, outside of the cottages.

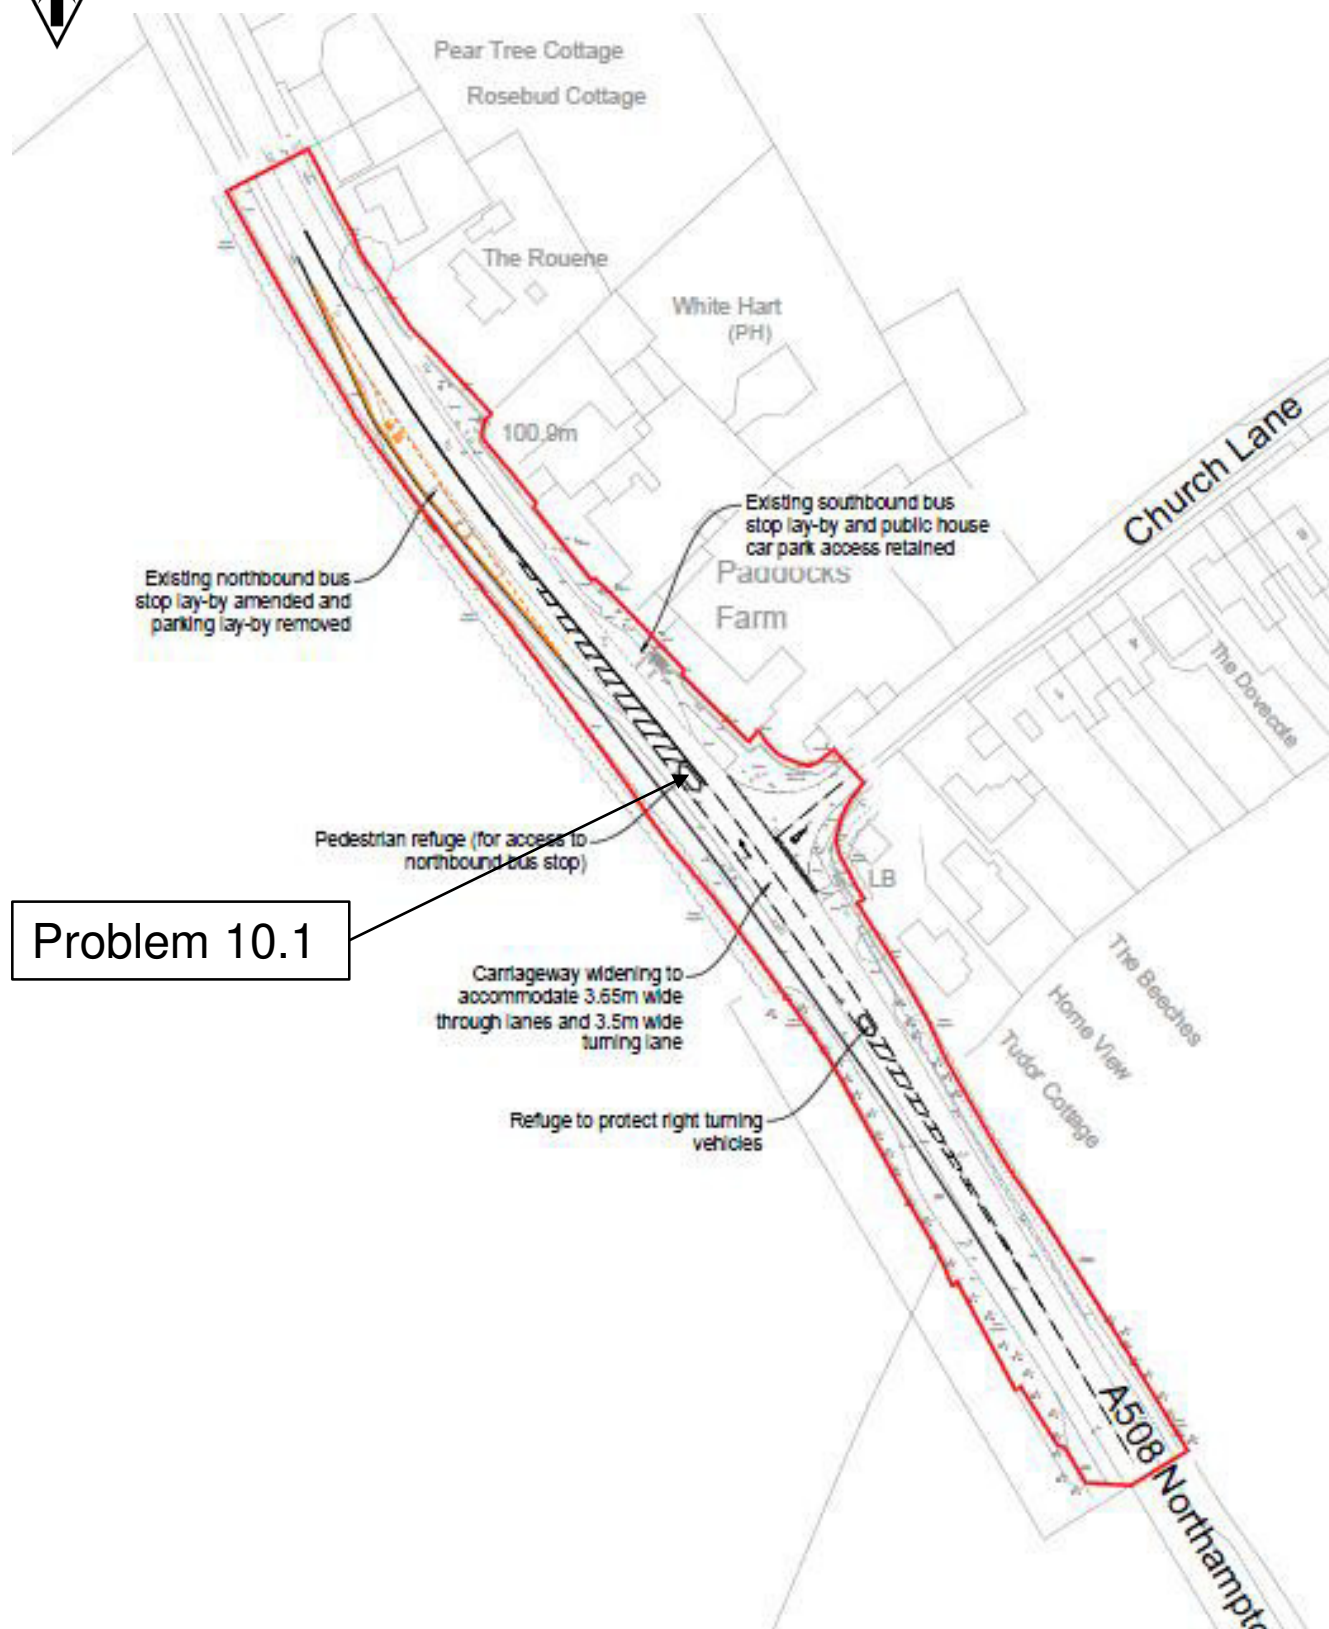
Location: A508 north of Church Lane (Figure 8).

Summary: Refuge could be damaged by agricultural vehicles.

There is a refuge provided on the A508 directly to the north of the Church Lane junction, to allow pedestrian access to the southbound bus stop. During the site visit, a large tractor was witnessed turning right out of Church Lane onto the A508 which used a large amount of carriageway. If the refuge is provided close to the junction this could result in the refuge being run over by these large vehicles, potentially damaging the bollards or the kerbing, which could even leave parts of the kerb in the carriageway leaving a hazard to motorists and motorcyclists.

Ensure that the refuge is provided far enough from the junction to allow agricultural vehicles to enter and exit Church Lane.
