# **M1 Junction 15 West, Northampton**

Preliminary Ground Investigation Interpretive Report

312598- 03 (00)

**NOVEMBER 2014**

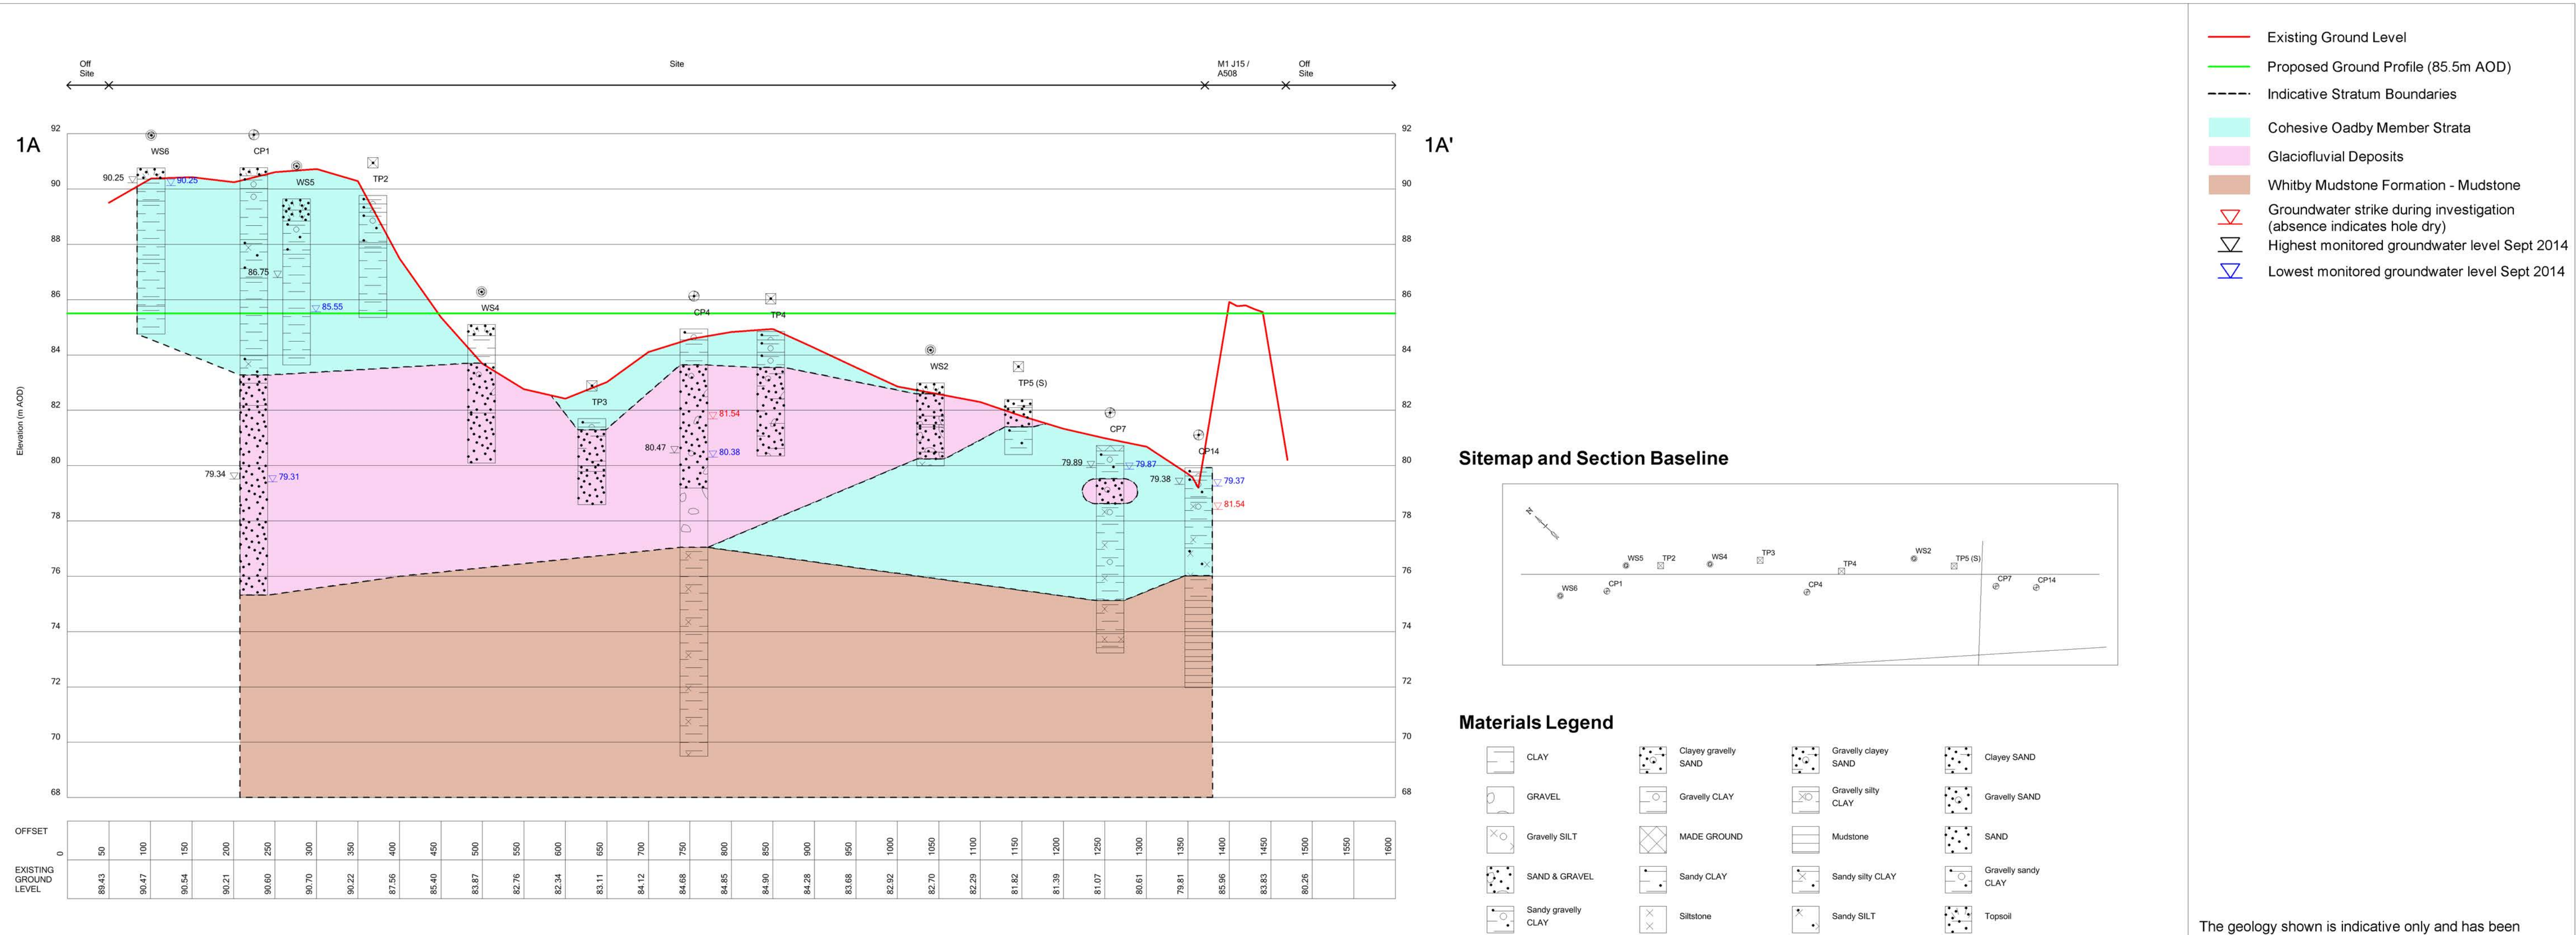
00	06.11.14	312598	SP	RG	DB
Rev	Date	Description	Drn	Chk	App
Junction 15 M1 West					
RSK					
Figure 8					
Indicative Ground Model					
Section 1A					
Not to Scale			REV 00

Solid Geology

Drift Geology

The geology shown is indicative only and has been tentatively defined from available exploratory hole data and available BGS mapping. The strata shown only include major geological units and do not show minor subordinate strata and bands. For full details of strata please refer to the borehole logs and data included in the Factual Ground Investigation Report.

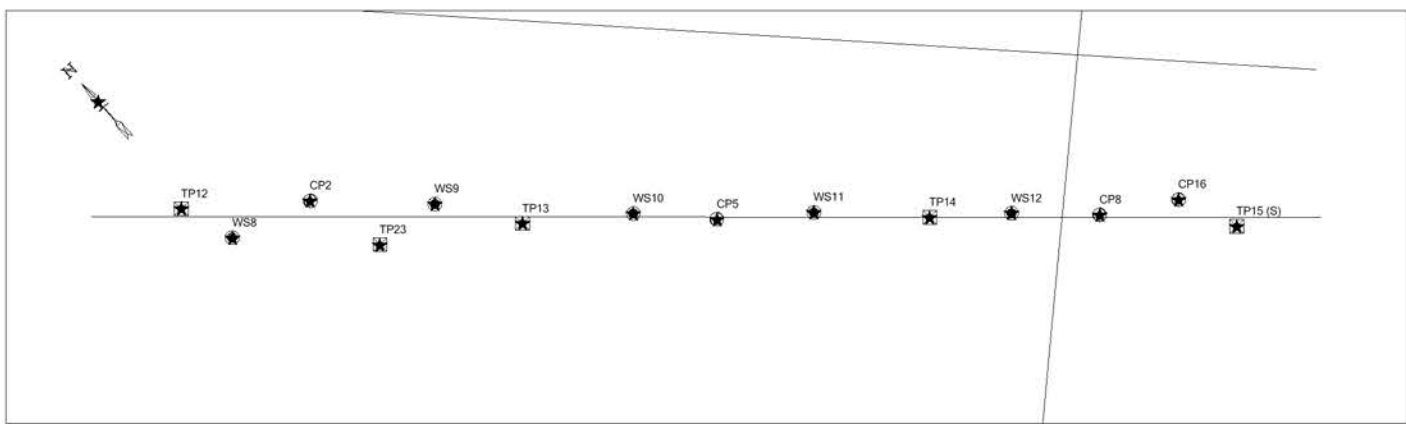
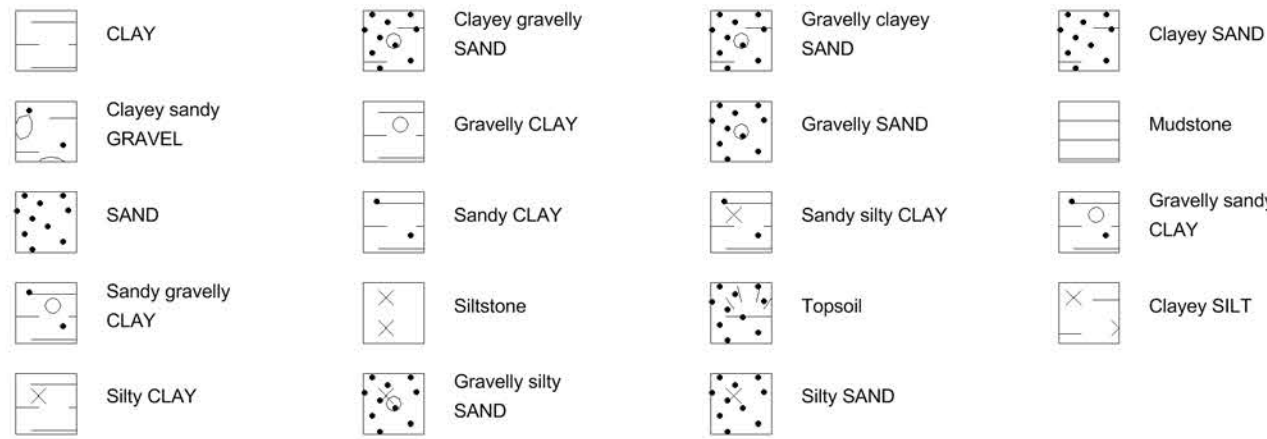
- The geology shown is indicative only and has been tentatively defined from available exploratory hole data and available BGS mapping.
- The strata shown only include major geological units and do not show minor subordinate strata and bands. For full details of strata please refer to the borehole logs and data included in the Factual Ground Investigation Report.

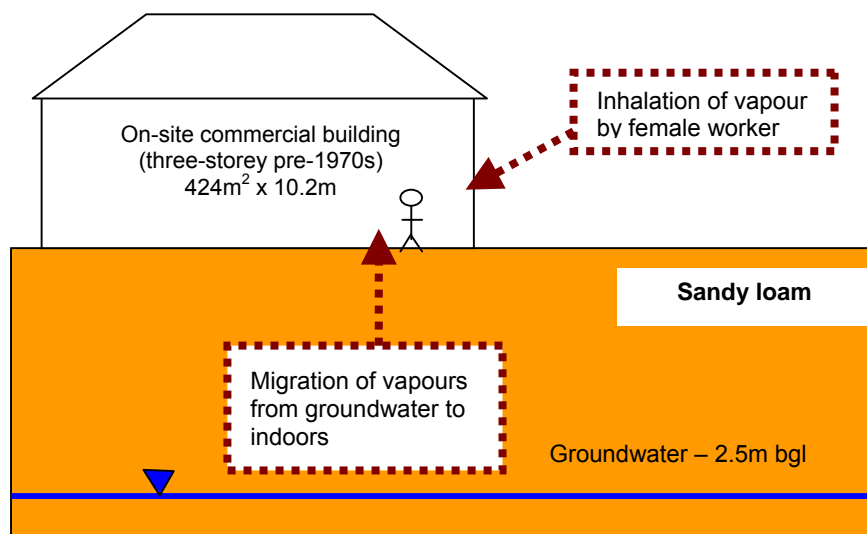
**Figure 2: GrAC conceptual model for RBCA commercial scenario**

Parameter	Unit	Value	Justification
<b>Receptor</b>			
Averaging time	Years	49	From Box 3.5, SR3 <sup>(3)</sup>
Receptor weight	kg	70	Female adult, Table 4.6, SR3 <sup>(3)</sup>
Exposure duration	Years	49	From Box 3.5, SR3 <sup>(3)</sup>
Exposure frequency	Days/yr	86.25	Weighted using occupancy period of 9 hours per day for 230 days of the year ((9hours x 230 days)/24 hours)
<b>Soil type – sandy loam</b>			
Total porosity	-	0.53	CLEA value for sandy loam. Parameters for sandy loam from Table 4.4, SR3 <sup>(3)</sup>
Volumetric water content	-	0.33	
Volumetric air content	-	0.20	
Dry bulk density	g cm <sup>-3</sup>	1.21	
Vertical hydraulic conductivity	cm s <sup>-1</sup>	3.56E-3	CLEA value for saturated conductivity of sandy loam, Table 4.4, SR3 <sup>(3)</sup>
Vapour permeability	m <sup>2</sup>	3.05E-12	Calculated for sandy loam using equations in Appendix 1, SR3 <sup>(3)</sup>
Canillary zone	m	0.1	Professional judgement

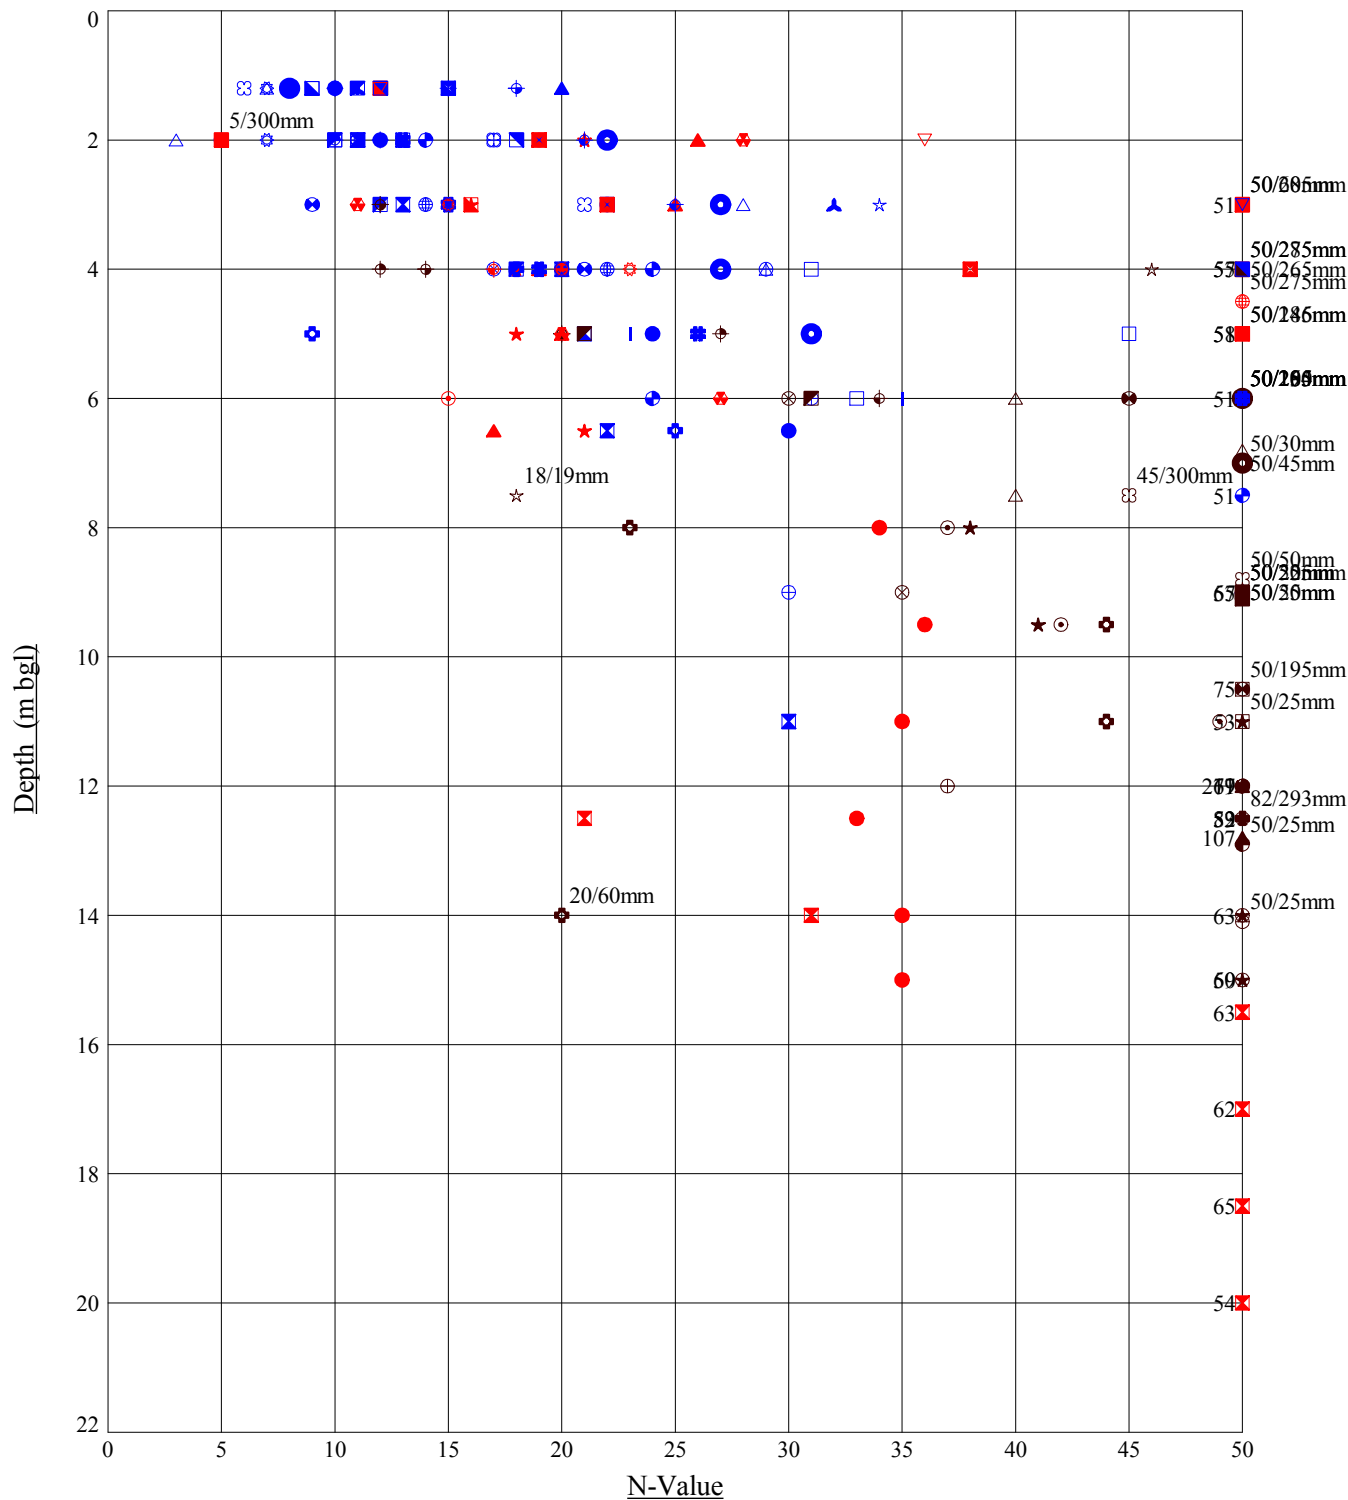
# STANDARD PENETRATION TEST (SPT N-Value) vs DEPTH

Geology code colour legend: Glaciofluvial Deposits, Oadby Member, Whitby Mudstone Formation

The SPT data is plotted against depth and level and presented graphically in Appendix J. As expected in most instances this indicates a progressive increase in SPT and corresponding strength of the strata with depth as the strata graduates from residual weathered soils to weak rock. Initially the weathered strata are noted to be firm to stiff where close to the surface and highly weathered.

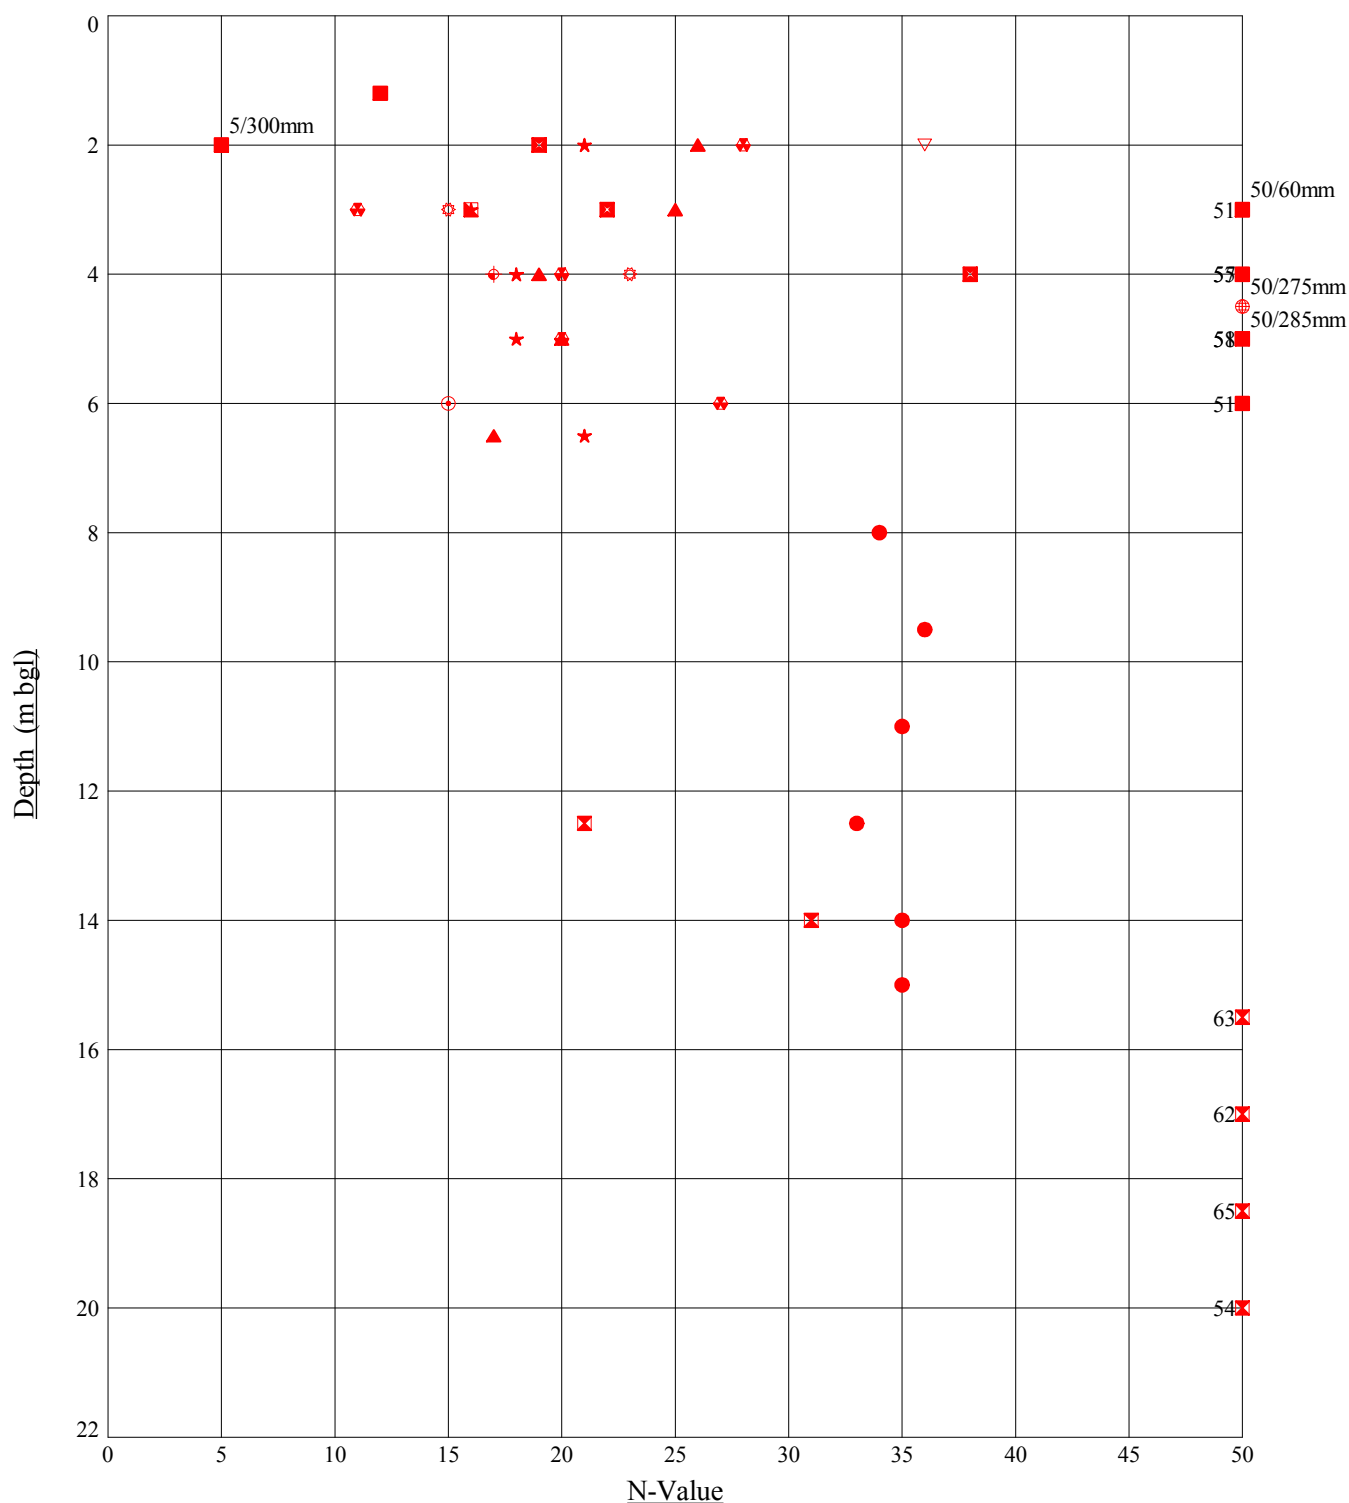
# STANDARD PENETRATION TEST (SPT N-Value) vs DEPTH

Key: ● = CP1, ☸ = CP15, ■ = CP16, ☒ = CP2, ▲ = CP3, ★ = CP4, ⊙ = CP5, ▣ = WS10, ▤ = WS11, ⬢ = WS16, ▽ = WS2, ⬥ = WS3, ◼ = WS4, ⊕ = WS7, ⊗ = WS8  
Data filtered by geological unit: **Glaciofluvial Deposits**

SPT 'N' values (depth plots presented separately)	5 - >50	49
Density term	Loose to Dense	
Notes: * dependant on depths and loadings, # samples noted to swell at low pressures,

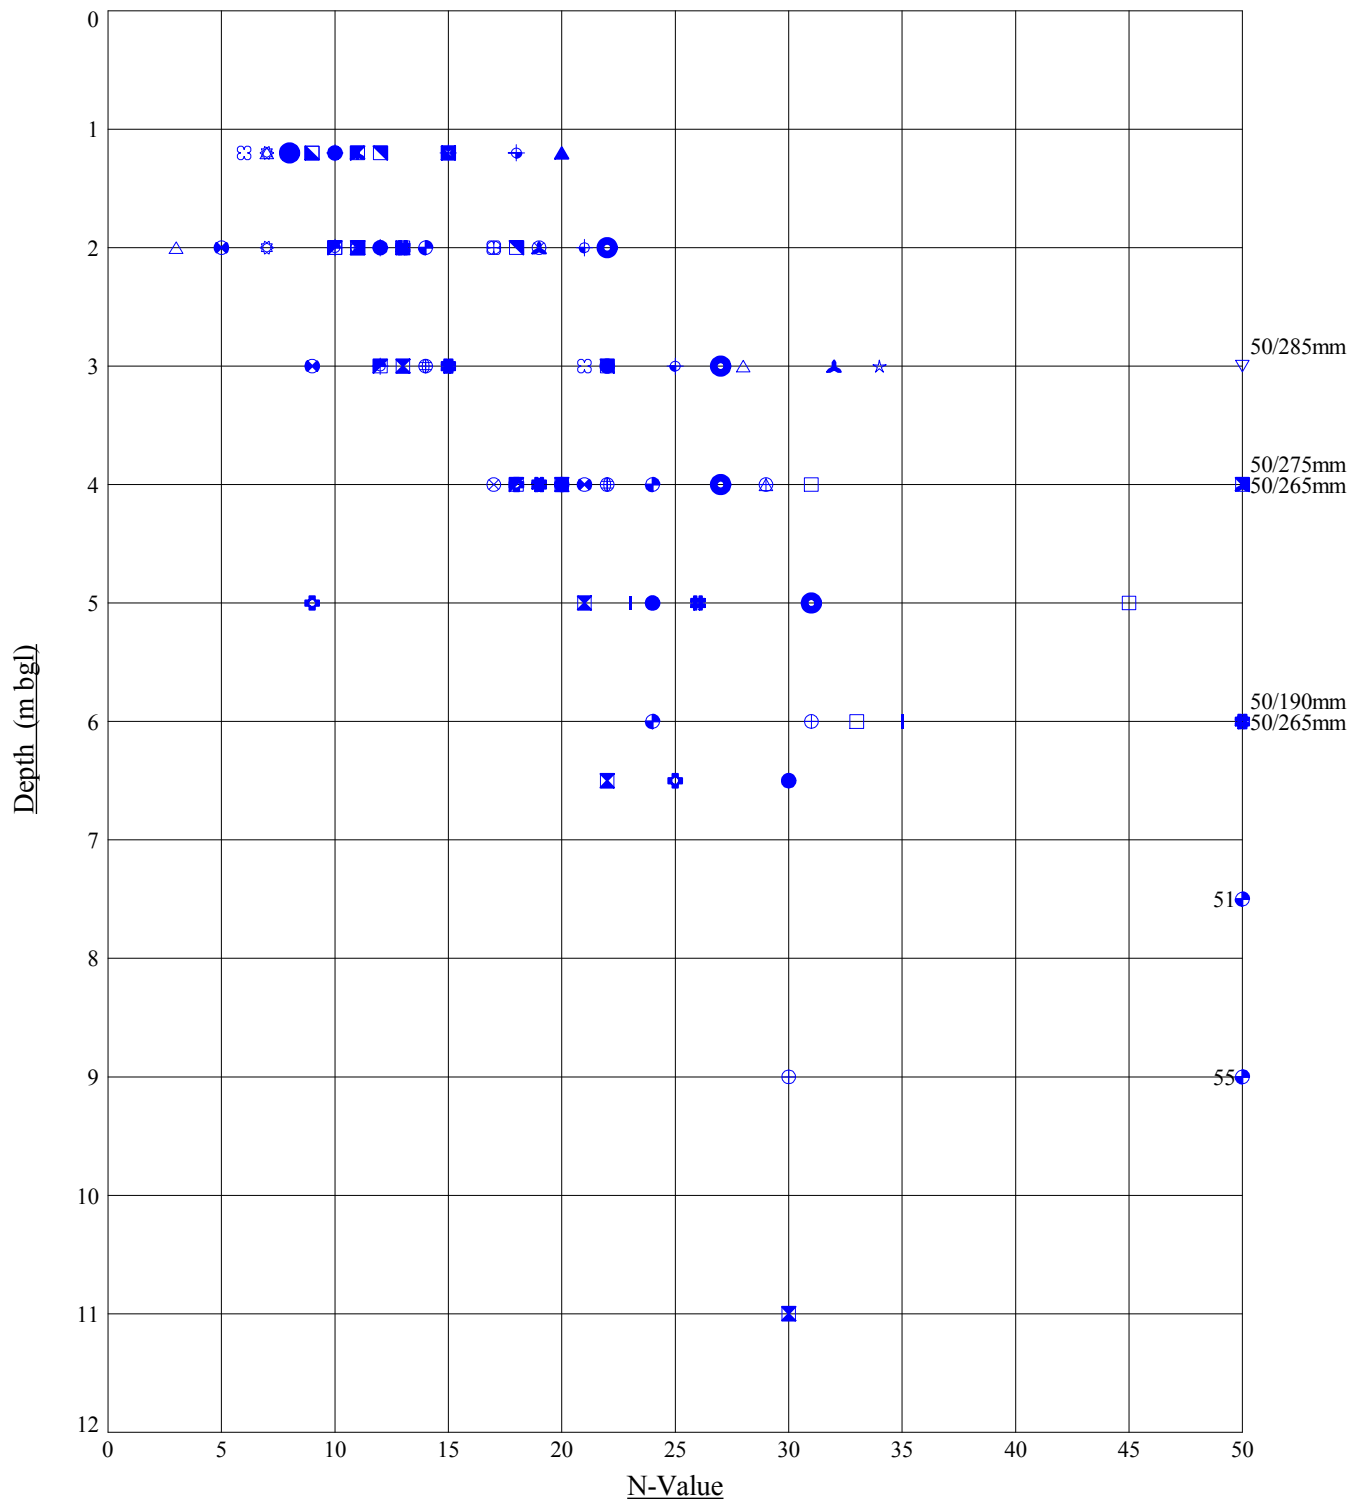
# STANDARD PENETRATION TEST (SPT N-Value) vs DEPTH

Key: ● = CP1, ⊕ = CP10, □ = CP11, ⊗ = CP12, ⊙ = CP13, ☆ = CP14, ☸ = CP15, ☒ = CP2, ▲ = CP3, ⊛ = CP6, ⊗ = CP7, △ = CP8, ⊗ = CP9, ▲ = WS1, ▣ = WS10, ▤ = WS11, ▥ = WS12, ▦ = WS13, ⬢ = WS14, ⬣ = WS15, ⬤ = WS16, ▽ = WS2, ⬥ = WS3, ⬦ = WS4, ⬧ = WS5, ⬨ = WS6, ⬩ = WS7, ⬪ = WS8, ⬫ = WS9

Data filtered by geological unit: **Oadby Member**

Re-compacted CBR – 4.5kg Rammer (%)	0.7 – 13.0 (20 - 29% mc)	10
Moisture Condition Value (MCV)	10.7 – 12.6 (24 - 29% Nat mc)	5
Moisture Condition Calibration (MCC) MCV 8 = MCV 13 =	29.00 – 31.90%mc 22.80 – 24.00%mc	3
SPT 'N' values (depth plots presented separately)	5 - >50	97
Undrained shear strength inferred from SPT 'N' values (kN/m <sup>2</sup> )	23 - >300	
Stiffness term	Soft to Very Stiff	
Undrained shear strength measured by triaxial testing (kN/m <sup>2</sup> ) – varies with depth	14 – 140 (av 78)	11
Bulk Density (Mg/m <sup>3</sup> )	1.87 – 2.28 (av 2.03)	
Natural Moisture Content at test	13 – 30 (av 23)	
Stiffness term	Very Soft to Stiff	
Undrained shear strength measured by	50 – 296 (av 157)	7

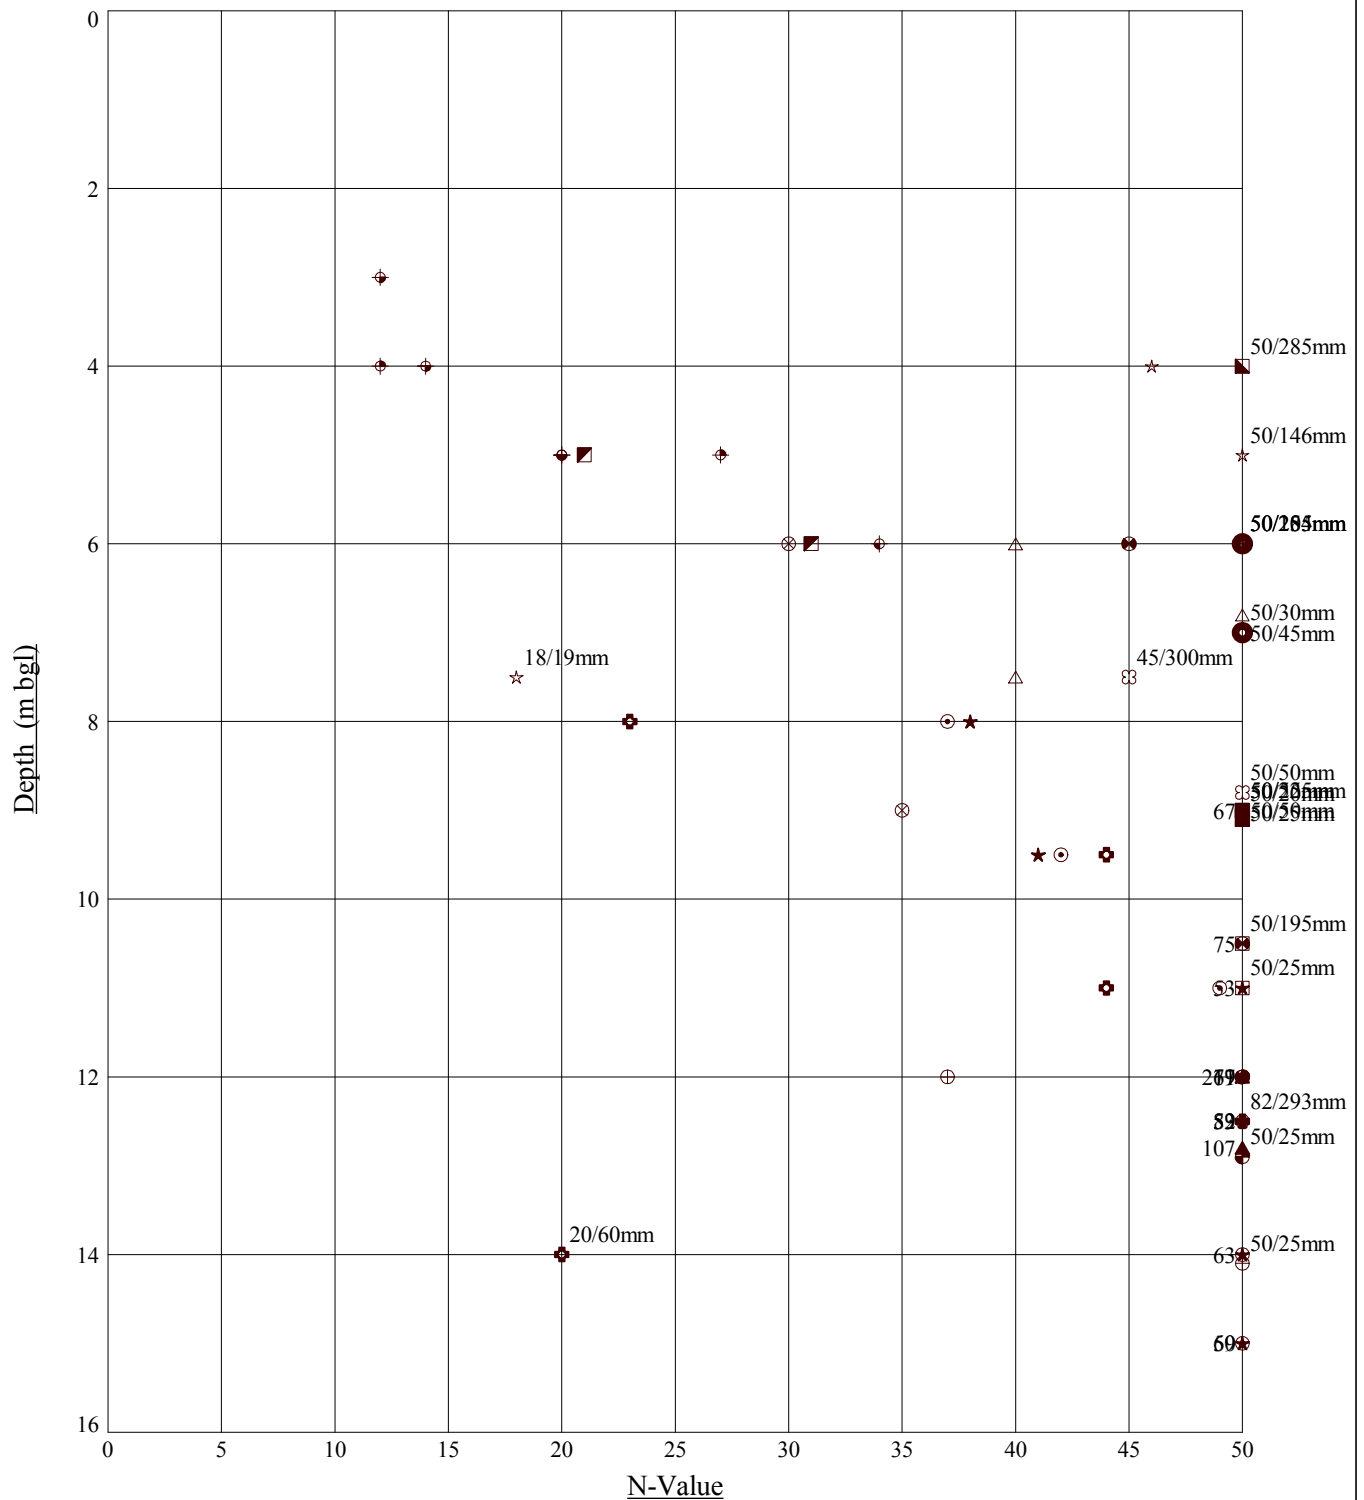
## STANDARD PENETRATION TEST (SPT N-Value) vs DEPTH

Key:  $\oplus$  = CP10,  $\square$  = CP11,  $\otimes$  = CP12,  $\oplus$  = CP13,  $\star$  = CP14,  $\boxtimes$  = CP15,  $\blacksquare$  = CP16,  $\blacktriangle$  = CP3,  $\star$  = CP4,  $\odot$  = CP5,  $\oplus$  = CP6,  $\odot$  = CP7,  $\triangle$  = CP8,  $\otimes$  = CP9,  $\blacksquare$  = WS11,  $\blacksquare$  = WS13,  $\oplus$  = WS14,  $\oplus$  = WS15,  $\oplus$  = WS16  
Data filtered by geological unit: **Whitby Mudstone Formation**

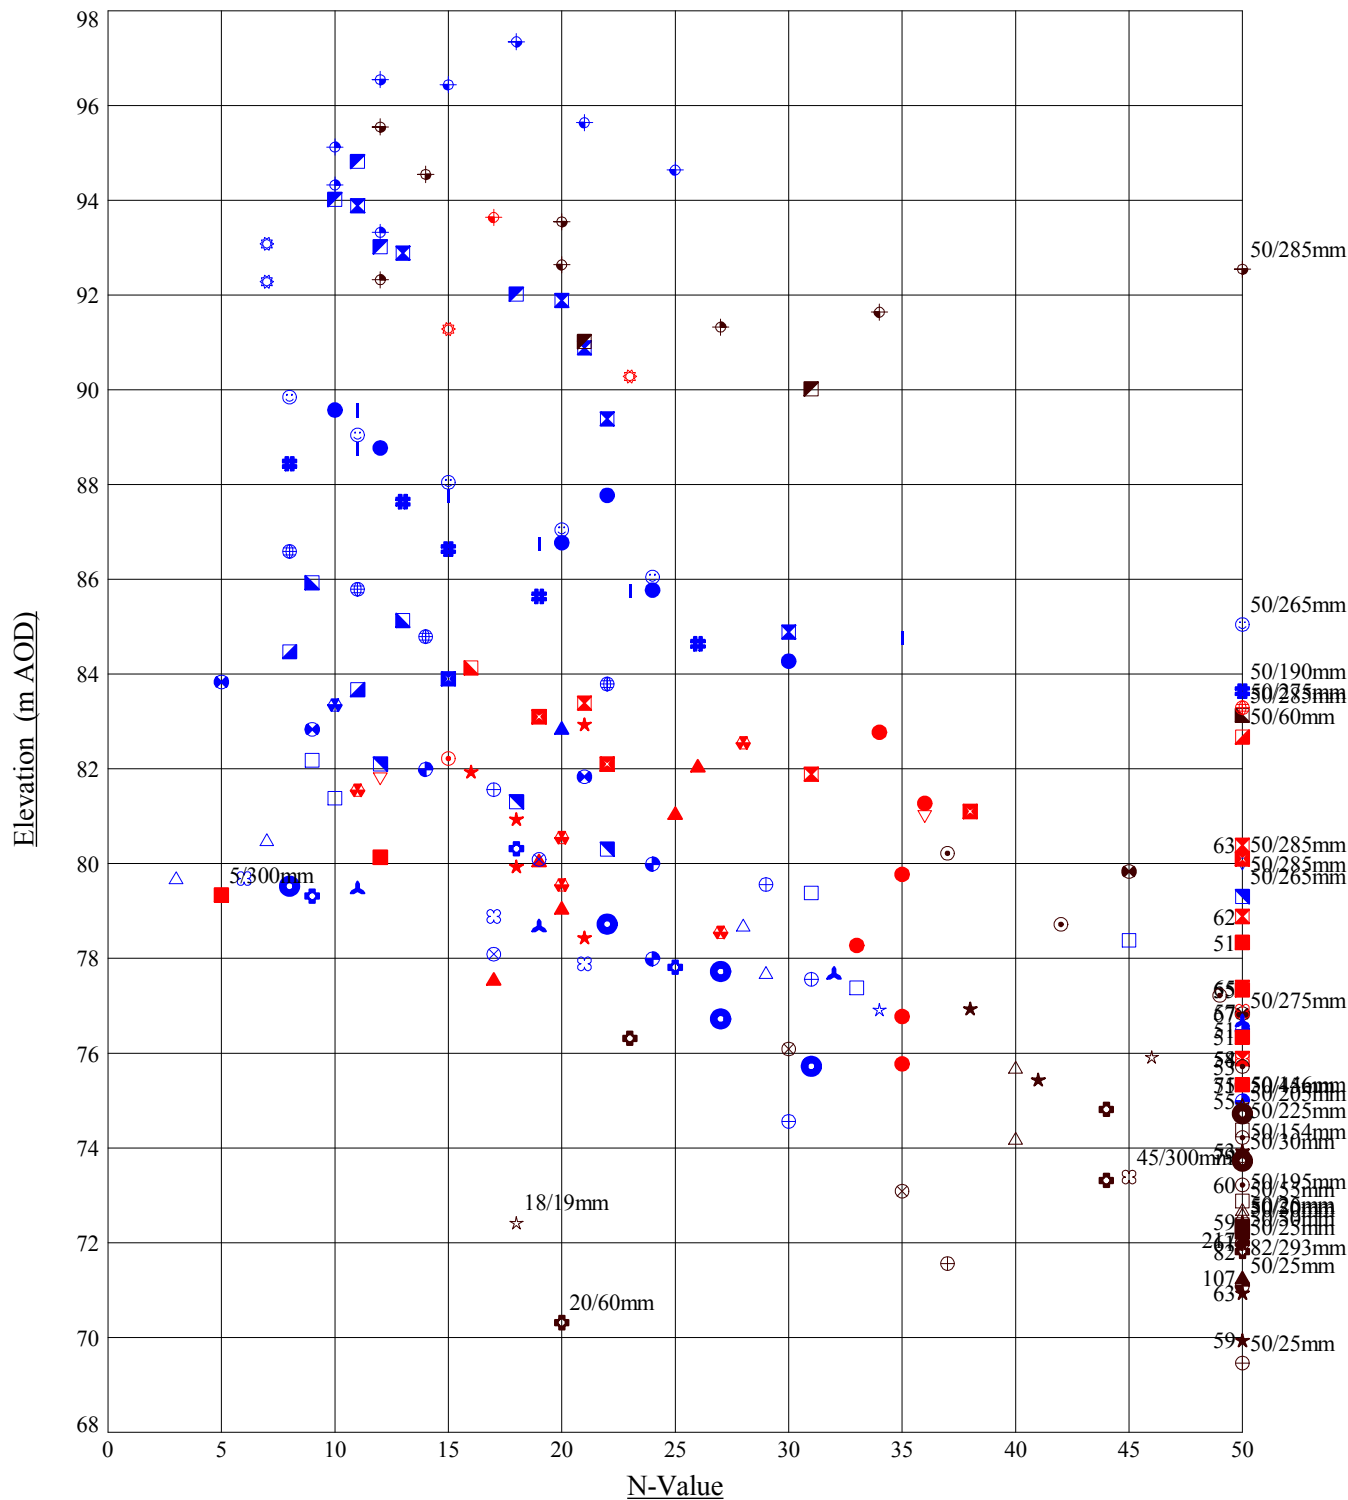
# STANDARD PENETRATION TEST (SPT N-Value) vs ELEVATION

Key: ● = CP1, ⊕ = CP10, □ = CP11, ⊗ = CP12, ⊙ = CP13, ☆ = CP14, ⋈ = CP15, ■ = CP16, ⊠ = CP2, ▲ = CP3, ★ = CP4, ⊙ = CP5, ⊕ = CP6, ⊙ = CP7, △ = CP8, ⊗ = CP9, ▲ = WS1, ■ = WS10, ■ = WS11, ■ = WS12, ■ = WS13, ⊕ = WS14, ⊕ = WS15, ⊕ = WS16, ▽ = WS2, ⊕ = WS3, ⊠ = WS4, ⊕ = WS5, I = WS6, ⊕ = WS7, ⊕ = WS8, ⊕ = WS9

Geology code colour legend: Glaciofluvial Deposits, Oadby Member, Whitby Mudstone Formation

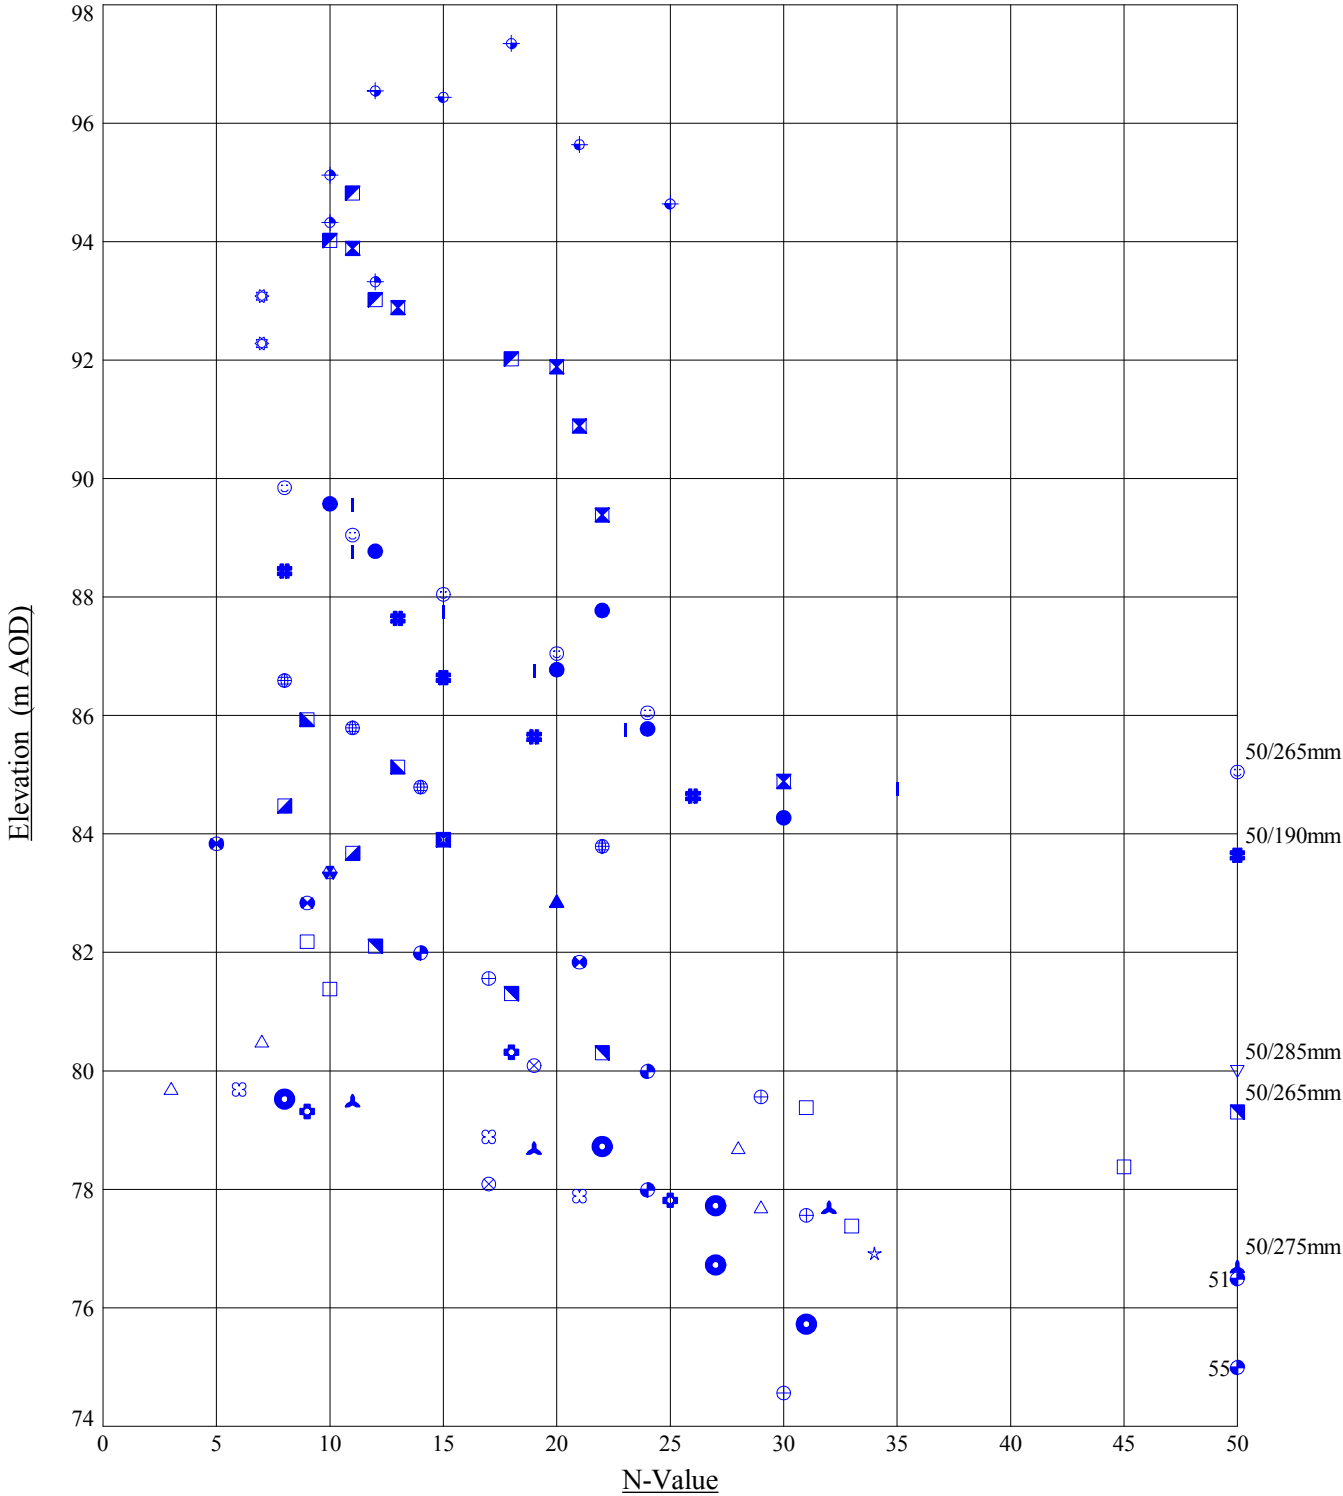
# STANDARD PENETRATION TEST (SPT N-Value) vs ELEVATION

Key: ● = CP1, ⊕ = CP10, □ = CP11, ⊗ = CP12, ⊙ = CP13, ☆ = CP14, ☼ = CP15, ✕ = CP2, ▲ = CP3, ⊛ = CP6, ⊗ = CP7, △ = CP8, ⊗ = CP9, ▲ = WS1, ▣ = WS10, ▤ = WS11, ▥ = WS12, ▦ = WS13, ⊕ = WS14, ⊕ = WS15, ⊕ = WS16, ▽ = WS2, ⊛ = WS3, ▣ = WS4, ⊛ = WS5, I = WS6, ⊕ = WS7, ⊛ = WS8, ⊙ = WS9  
Data filtered by geological unit: **Oadby Member**

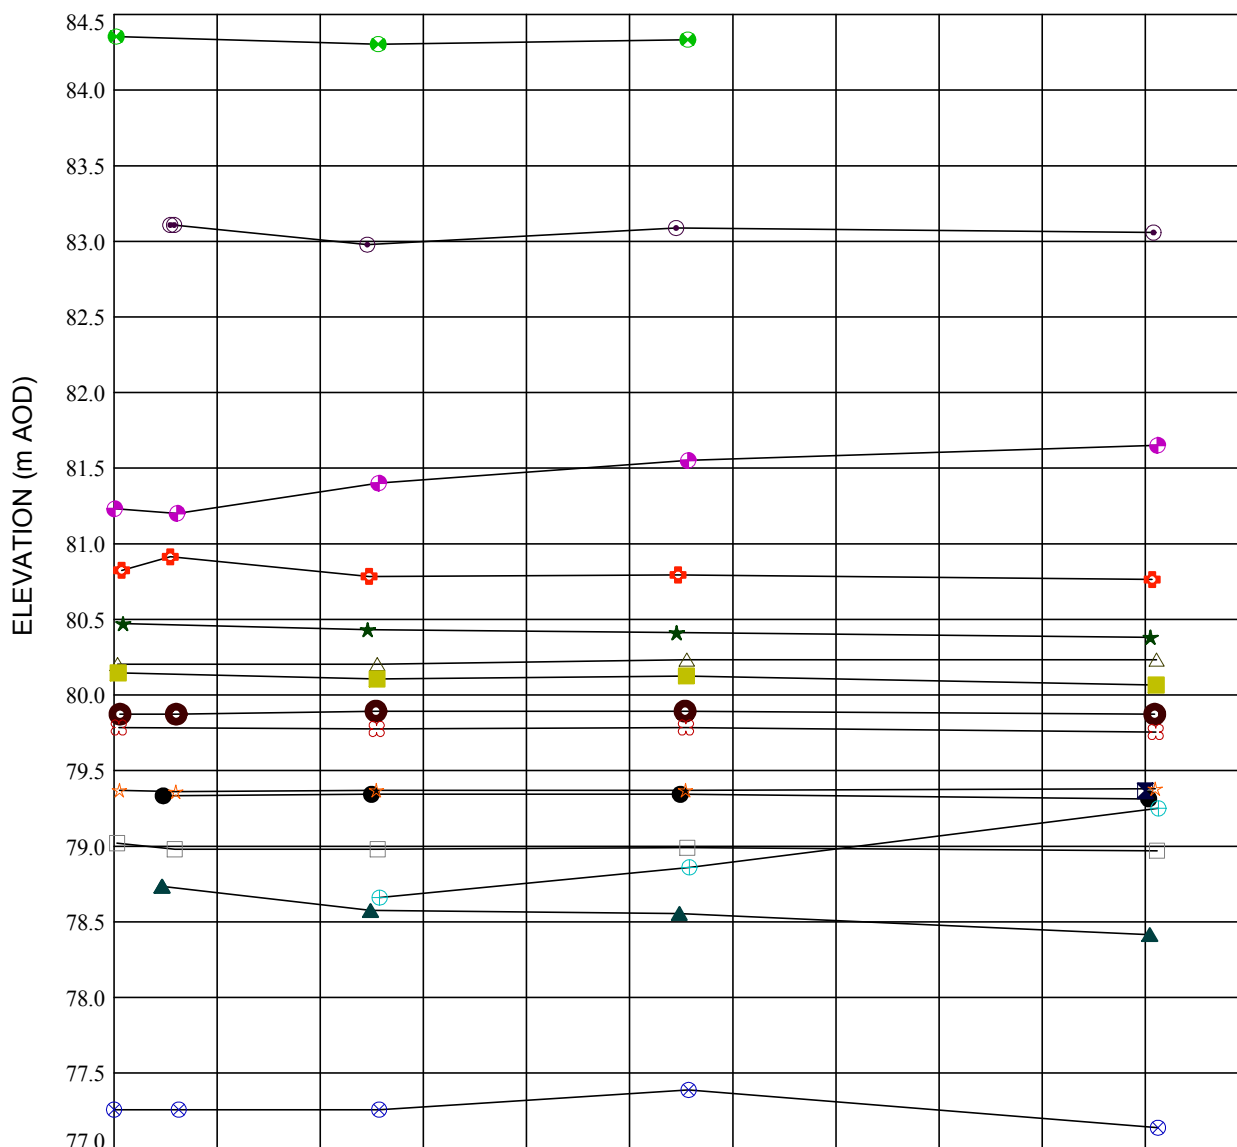
# BOREHOLE WATER OBSERVATIONS

PLOT OF WATER LEVEL (ELEVATION) AGAINST TIME

Where not listed, exploratory holes did not encounter groundwater strikes during formation. It should be noted that the speed of drilling and casing of holes can often mask minor seepages and water strikes. Indeed the addition of water within cable percussion boreholes to allow drilling to progress through granular deposits may obscure water strikes, however major water strikes would be evident.

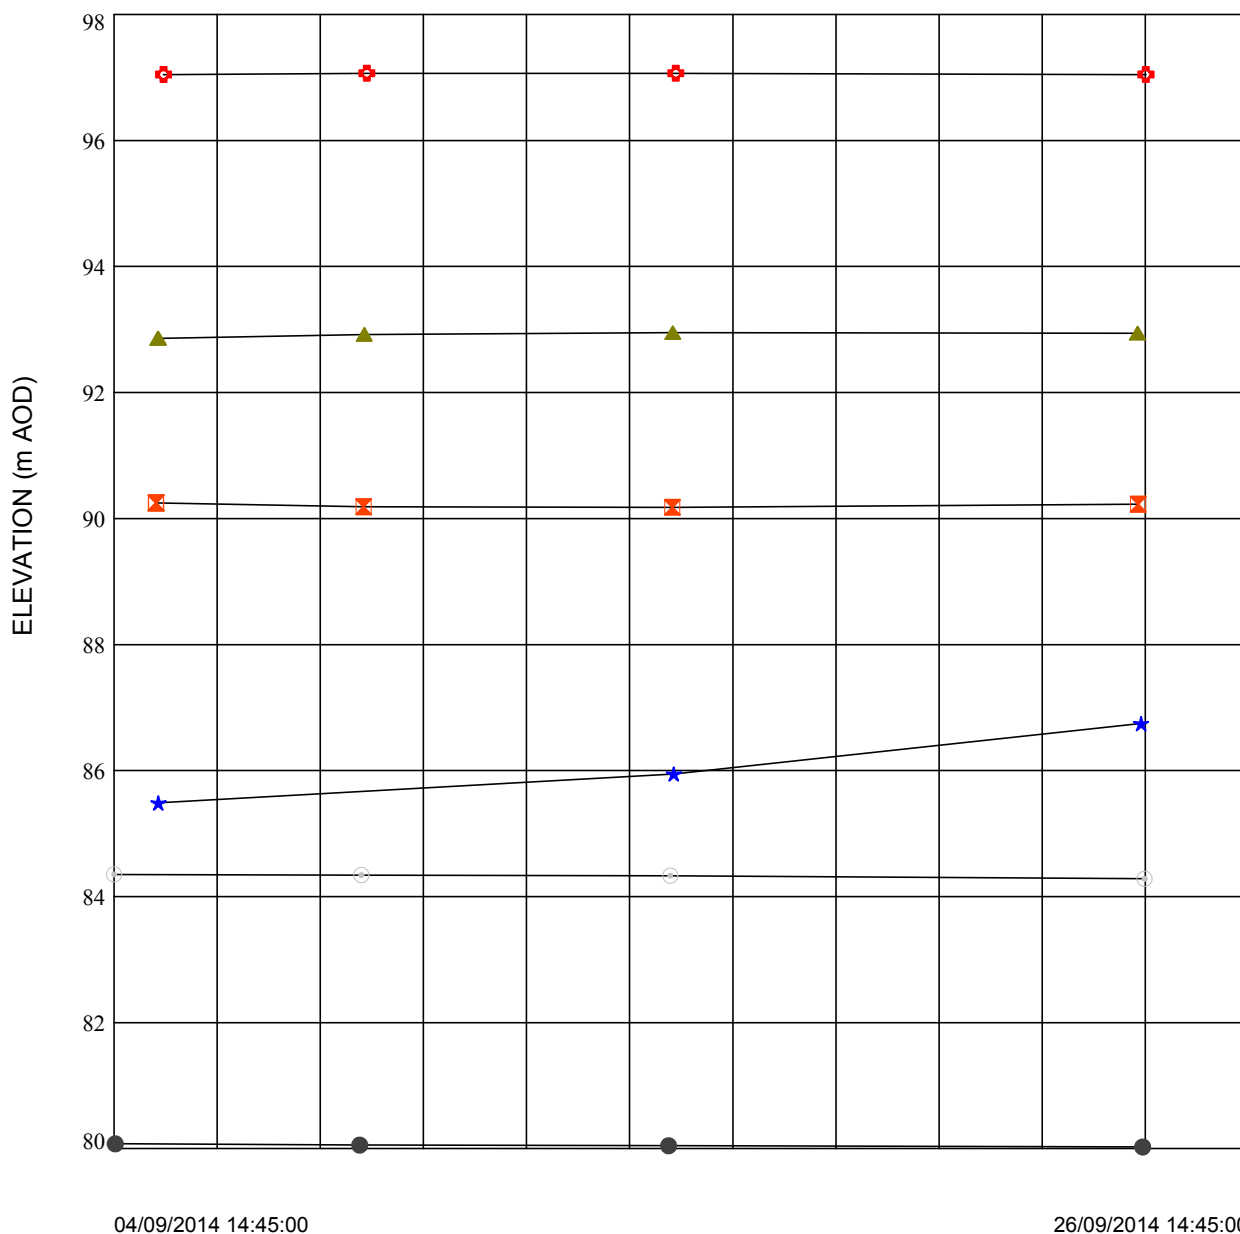
# BOREHOLE WATER OBSERVATIONS

PLOT OF WATER LEVEL (ELEVATION) AGAINST TIME

● = 'WS3'    ⌗ = 'WS6'    ▲ = 'WS8'    ★ = 'WS9'    ⊙ = 'WS11'    ⊕ = 'WS15'
