# **M1 Junction 15 West, Northampton**

## **Revised Junction Design**

Preliminary sources study report

Project no. 313588-02(02)

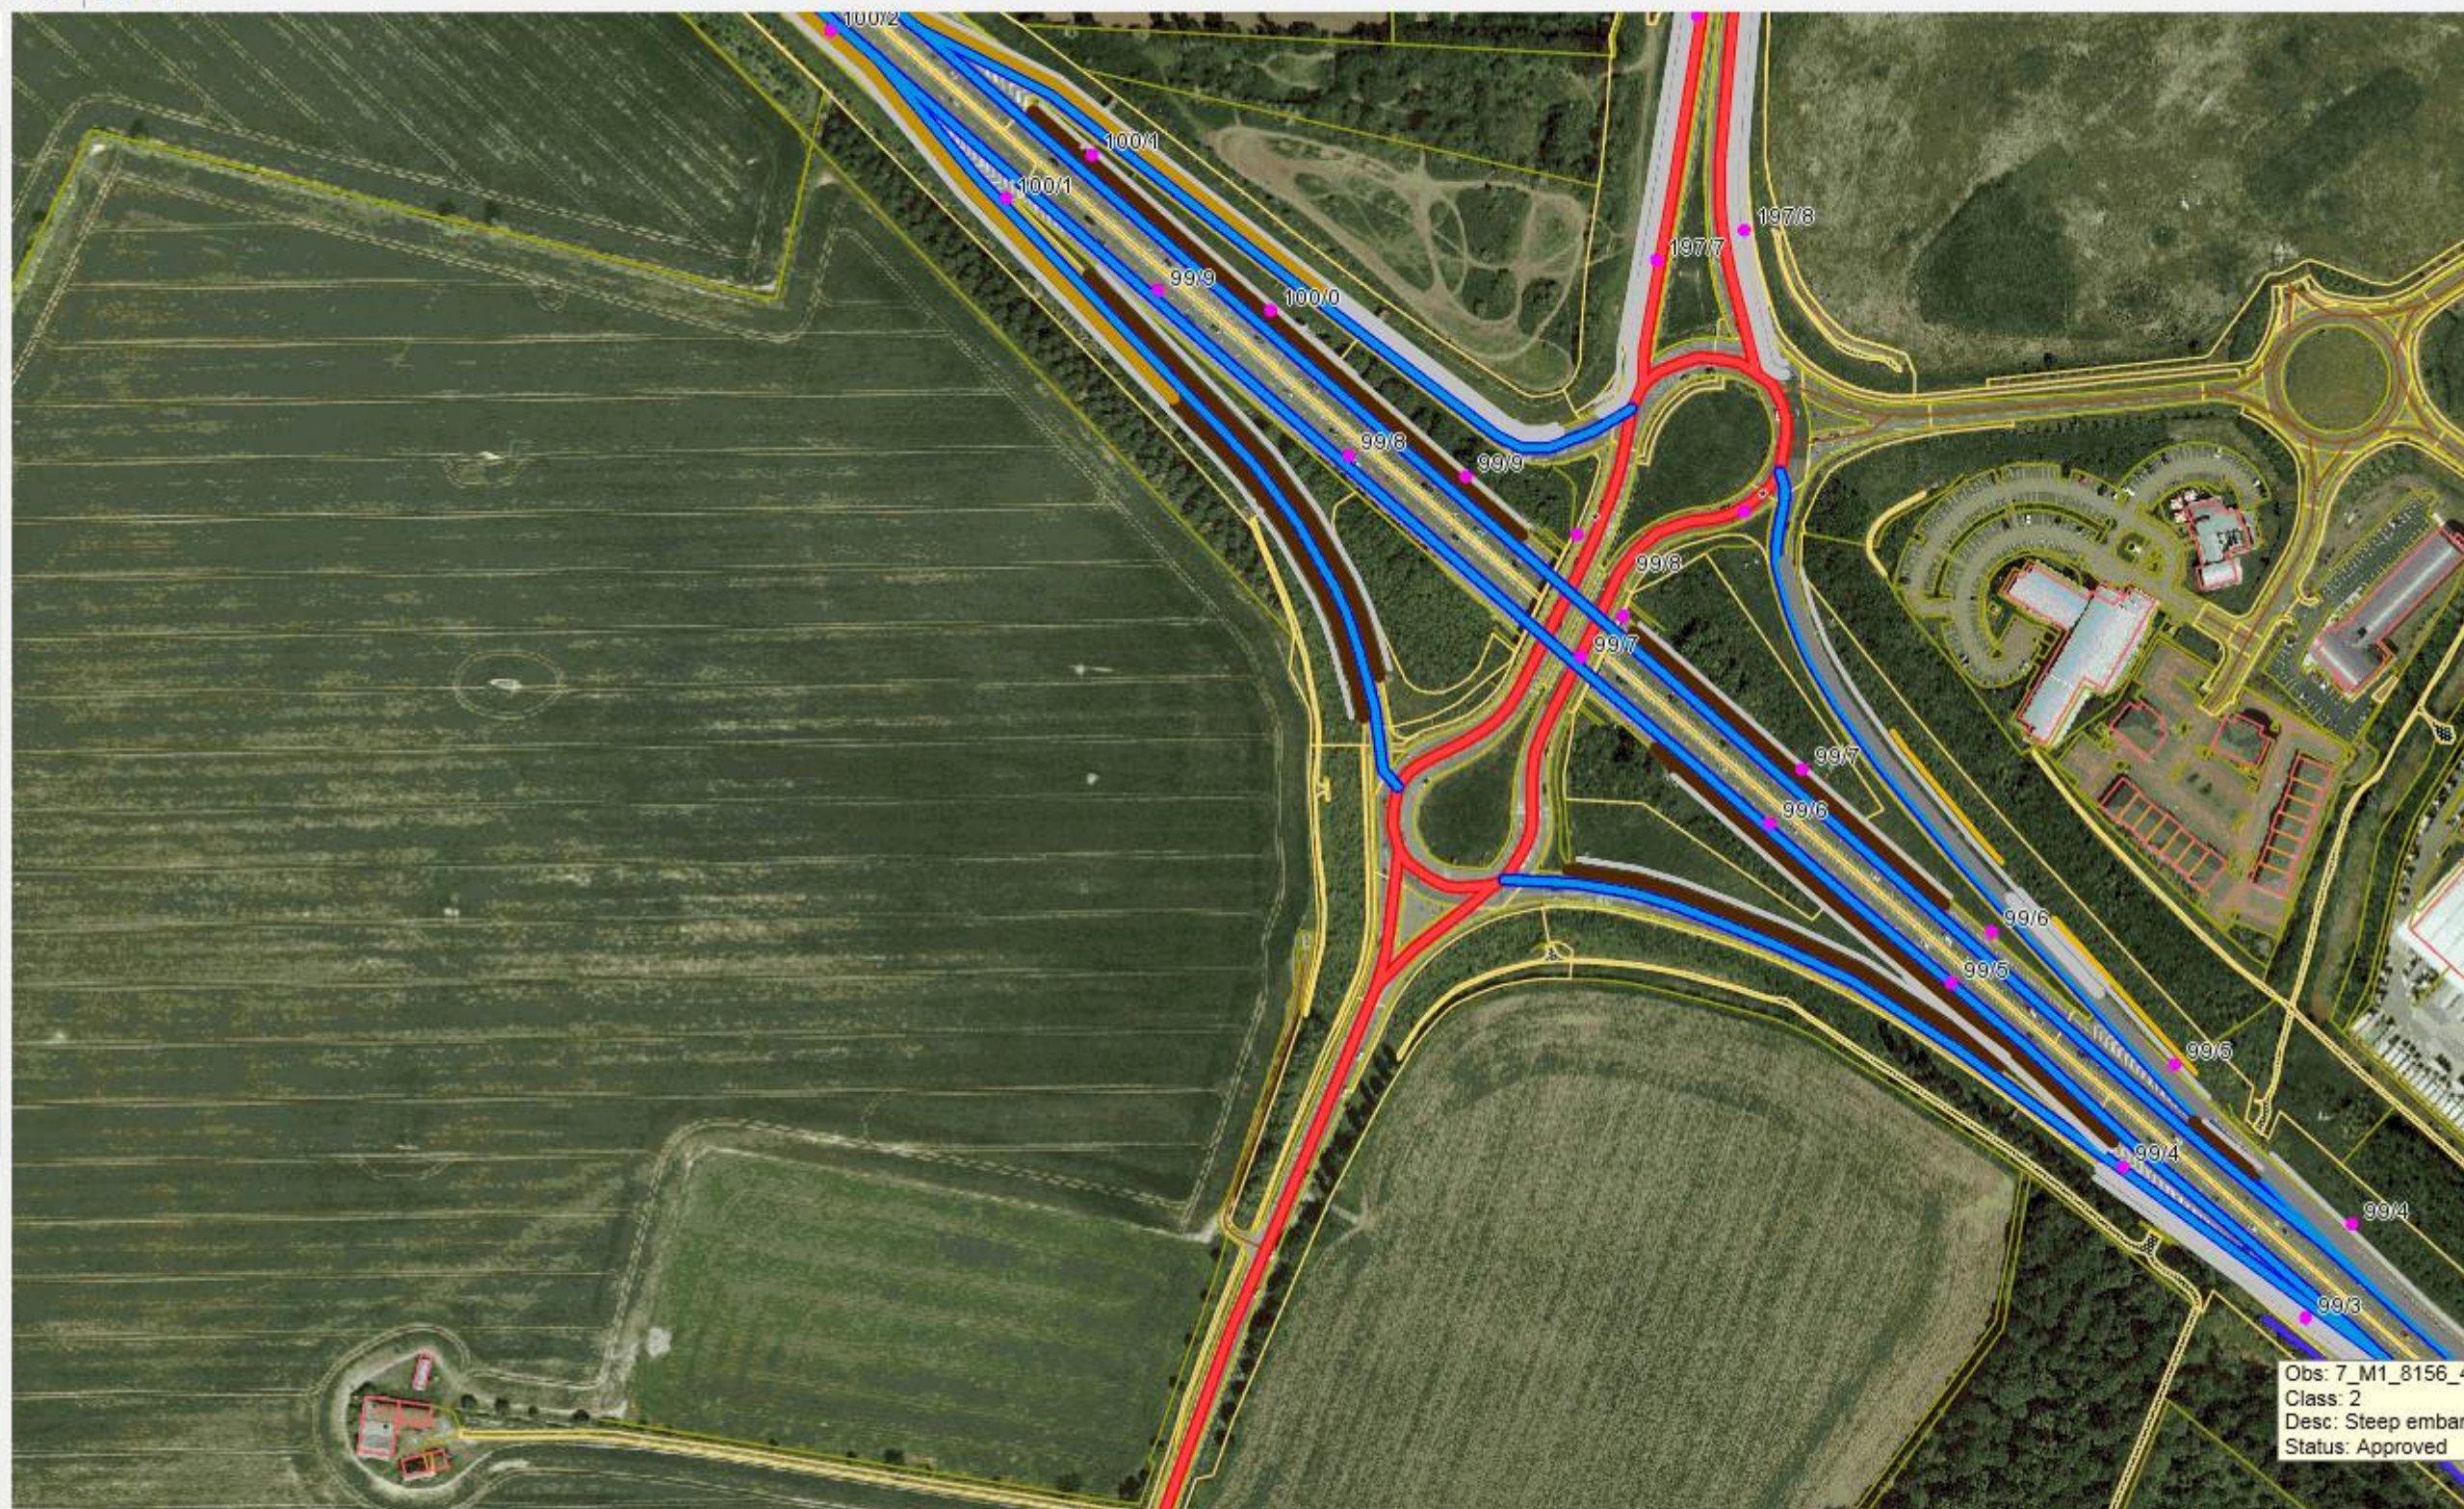
Obs: 7\_M1\_8156\_41  
 Class: 2  
 Desc: Steep embank  
 Status: Approved

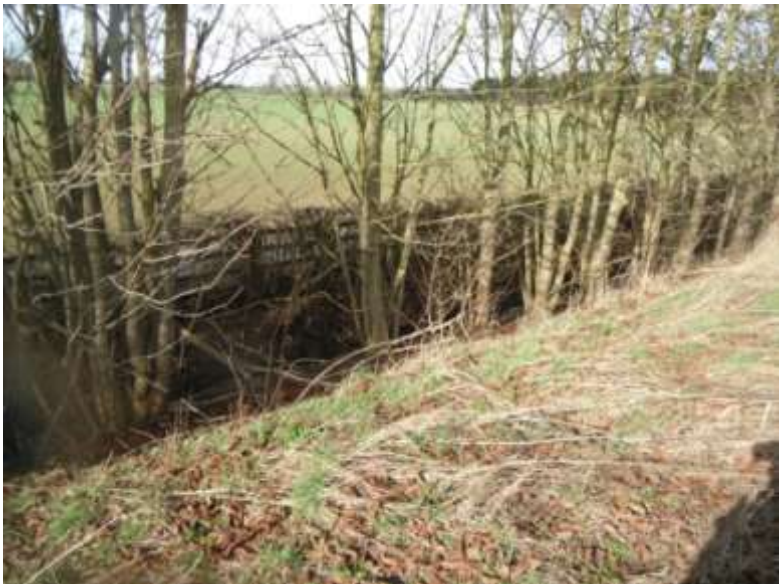
It is recommended that further investigation is undertaken to examine the existing embankment fill materials and to confirm its chemical make up at enabling works stage where uncovered.

Opportunities should be taken to install ground gas and groundwater monitoring wells where ever possible to confirm the current ground model and conditions beneath the site likely to be disturbed or affected by the proposed junction changes.

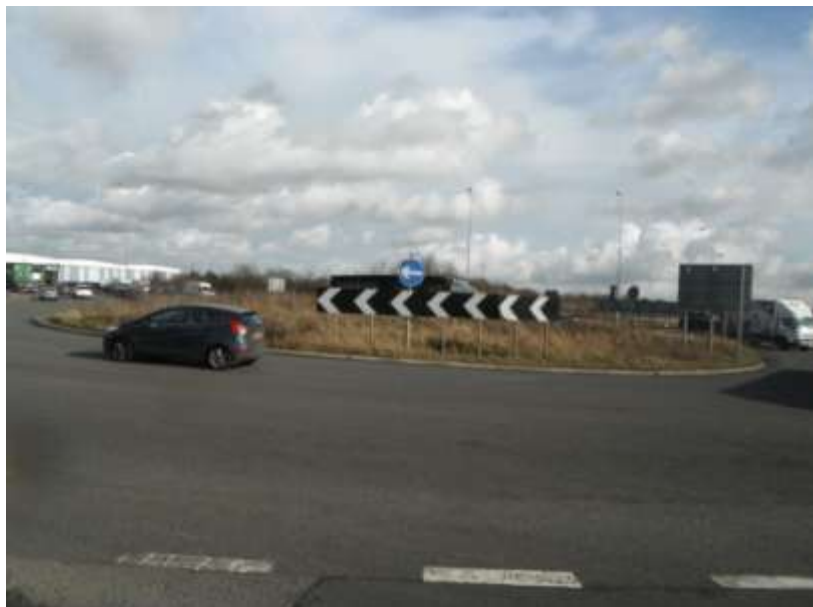
## **7 ASSESSMENT OF GEOTECHNICAL RISKS**

### **7.1 Preliminary geohazard and geotechnical assessment**

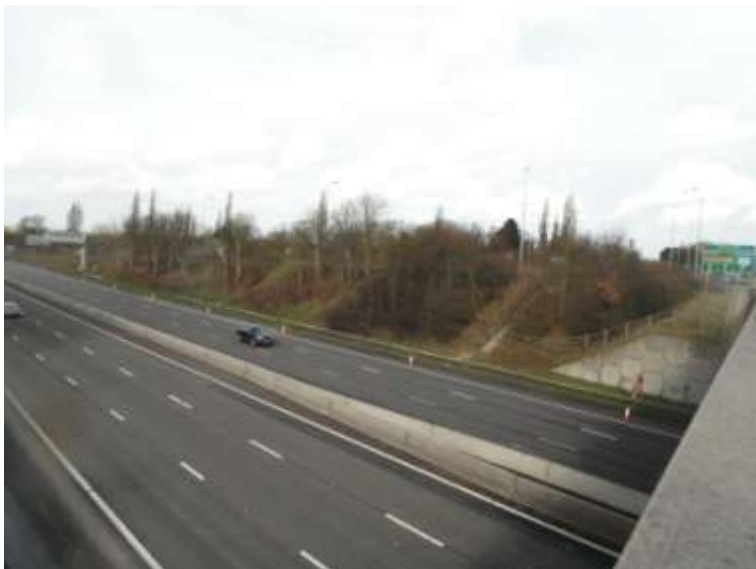
#### **7.1.1 Mining and natural cavities**

#### **7.1.2 Man made voids or obstructions**

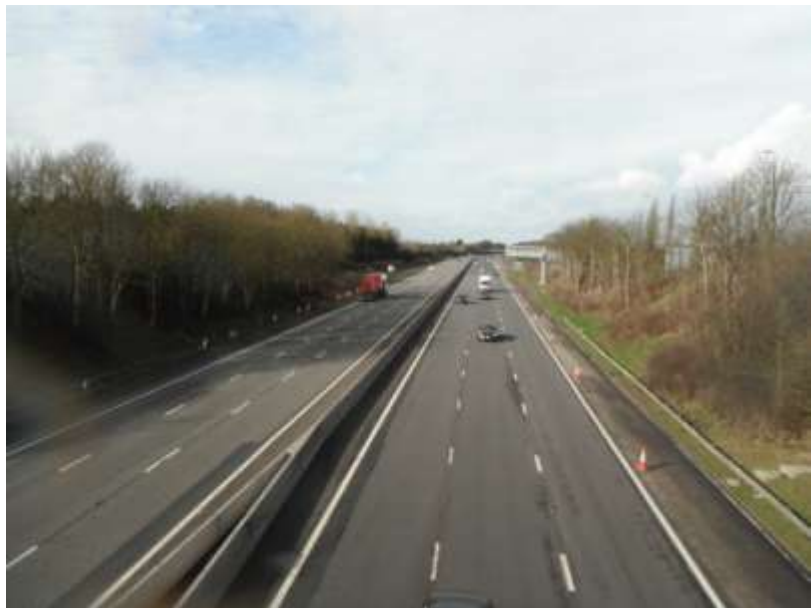
Due to the nature of the proposed revisions across the junction, some form of earthworks is anticipated to be required to achieve the proposed redevelopment of the site.

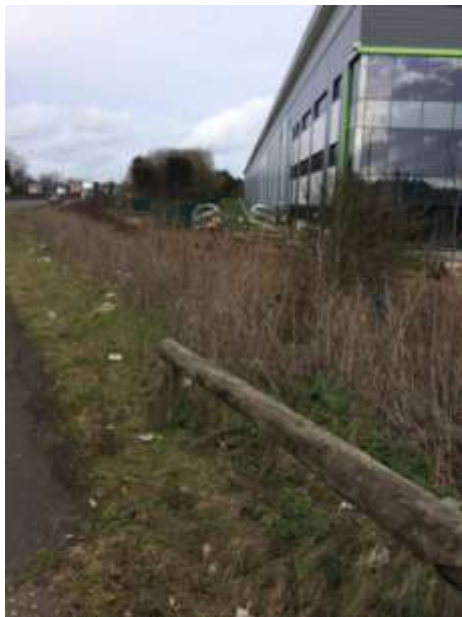
#### **7.1.4 Existing cut slopes**

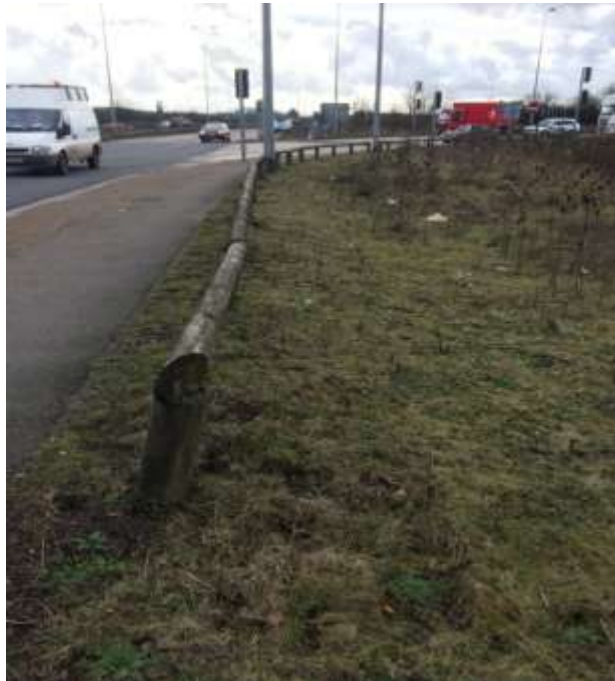
#### **7.1.5 Existing embankment slopes**

Widening of the existing embankments will require earthmoving in typically restrictive spaces adjacent to the present infrastructure at the site. Further investigation of the strata immediately adjacent to and beneath these embankment extensions as well as into the adjoining embankments will be necessary to allow assessment of the proposed future embankment stability and settlement and to facilitate detailed designs to be formulated.

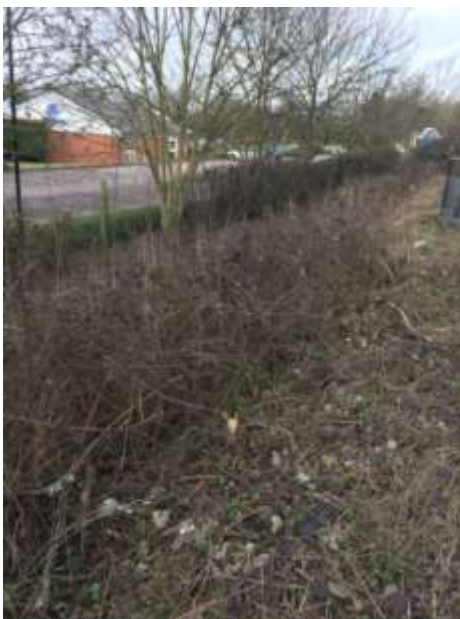
Embankment slopes must be designed appropriately with regard to the stability of the soils being used to construct the embankment and take account of the strength of the underlying foundation soils and adjoining embankments and the presence of any adjacent features such as cuttings.

Targeted Ground Investigation is recommended to confirm the underlying ground conditions beneath the footprints of the proposed new embankment widening so that embankment foundation assessments with respect to settlement and slope stability may be made. Investigation is required to be undertaken in areas of cut material to assess the classification and suitability of cut materials for reuse to allow the embankment designs to be refined.

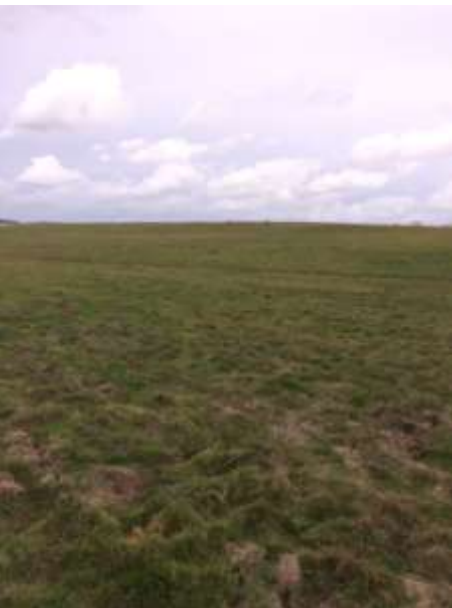
<b>Photo No.</b>  20	<b>Date:</b>  16.02.17

<b>Direction Photo Taken:</b>  Facing north-east		
<b>Description:</b> Wooton Quarry historical landfill adjacent north of Grange Park.

The only source of significance within the surrounding area is the historical Wooton Quarry landfill noted adjacent to and north of the site.

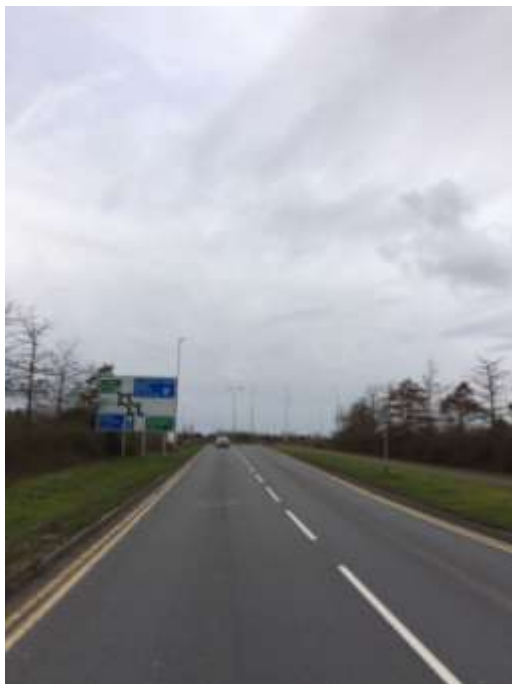
<b>Photo No.</b>  24	<b>Date:</b>  16.02.17

<b>Direction Photo Taken:</b>  Facing south-west		
<b>Description:</b> Photo taken on Saxon Avenue looking up to Junction 15. The photo clearly shows the road cambers up to the junction. Embankments noted adjacent to the road. Neighbouring land at an elevation of approximately 3/4m lower than road.

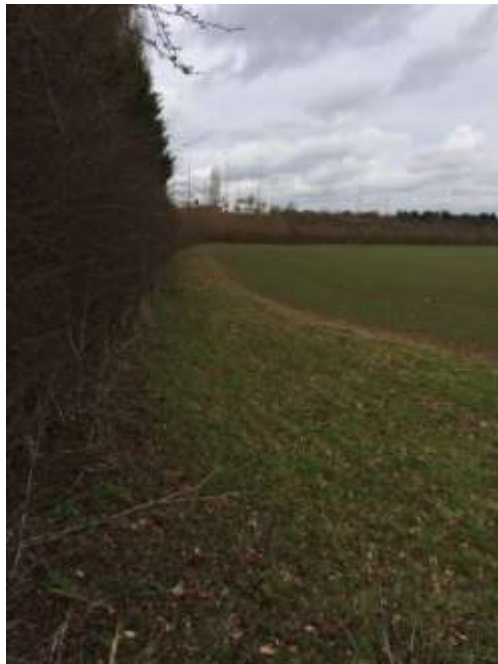
<b>Photo No.</b>  25	<b>Date:</b>  16.02.17

<b>Direction Photo Taken:</b>  Facing north		
<b>Description:</b> Agricultural field adjacent south-east of the site along the eastern limb of the A508. Photo clearly shows that at the time of the investigation the field was used for arable farming.

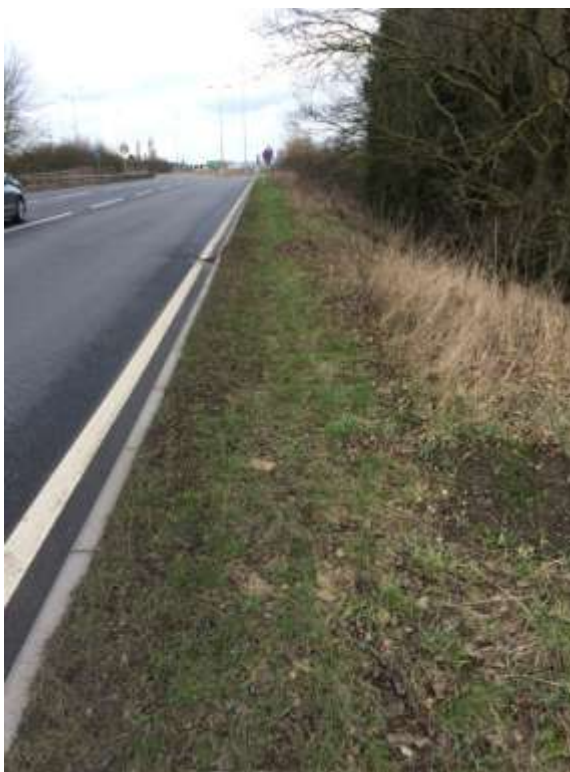
26	16.02.17	
<b>Direction Photo Taken:</b>  Facing north		
<b>Description:</b> A508 approach to the junction, clearly showing the road cambers up to the junction. Embankments noted to be present east and west of the road. At the junction the road is at an elevation of approximately 5m higher than the neighbouring farmland.

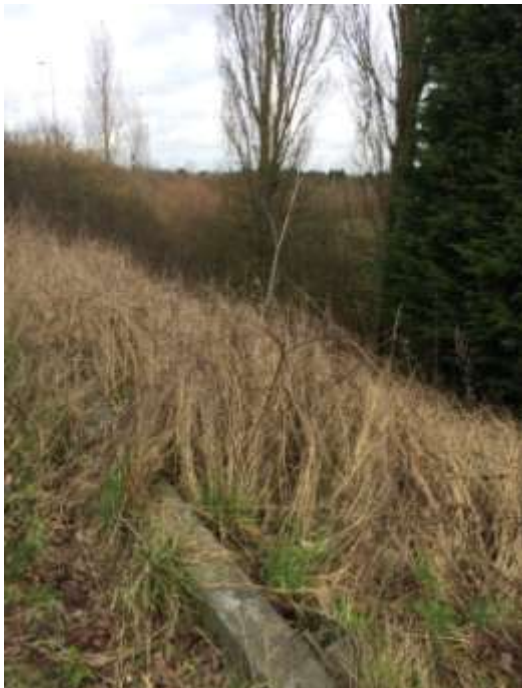
<b>Photo No.</b>  27	<b>Date:</b>  16.02.17

<b>Direction Photo Taken:</b>  Facing north-east		
<b>Description:</b> Embankment adjacent east of the A508, photo shows the elevation of the road in comparison to the neighbouring farmland and the dense vegetation which occupies the embankment.

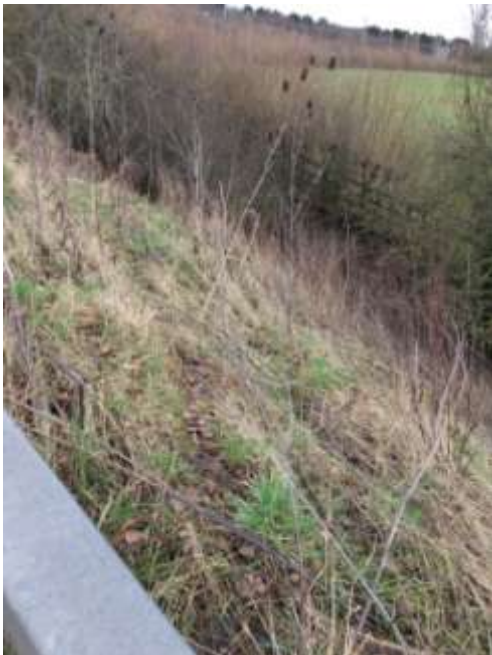
It is anticipated that the majority of the natural strata and made ground soils will not be conducive to infiltration drainage techniques as these are predominantly cohesive in nature.

A Ground Investigation report and Geotechnical Interpretative report produced by Symonds Group Ltd (dated March/ June 1999) is available and was undertaken previously at the Junction.
